APEX GEOSCIENCE CONSULTANTS LTD.

Detailed Terrain Stability Field Review

Spur 1 and 2 and associated Block A080
Glade/Rover Area
For
Kalesnikoff Lumber Company Ltd.

09/20/2019

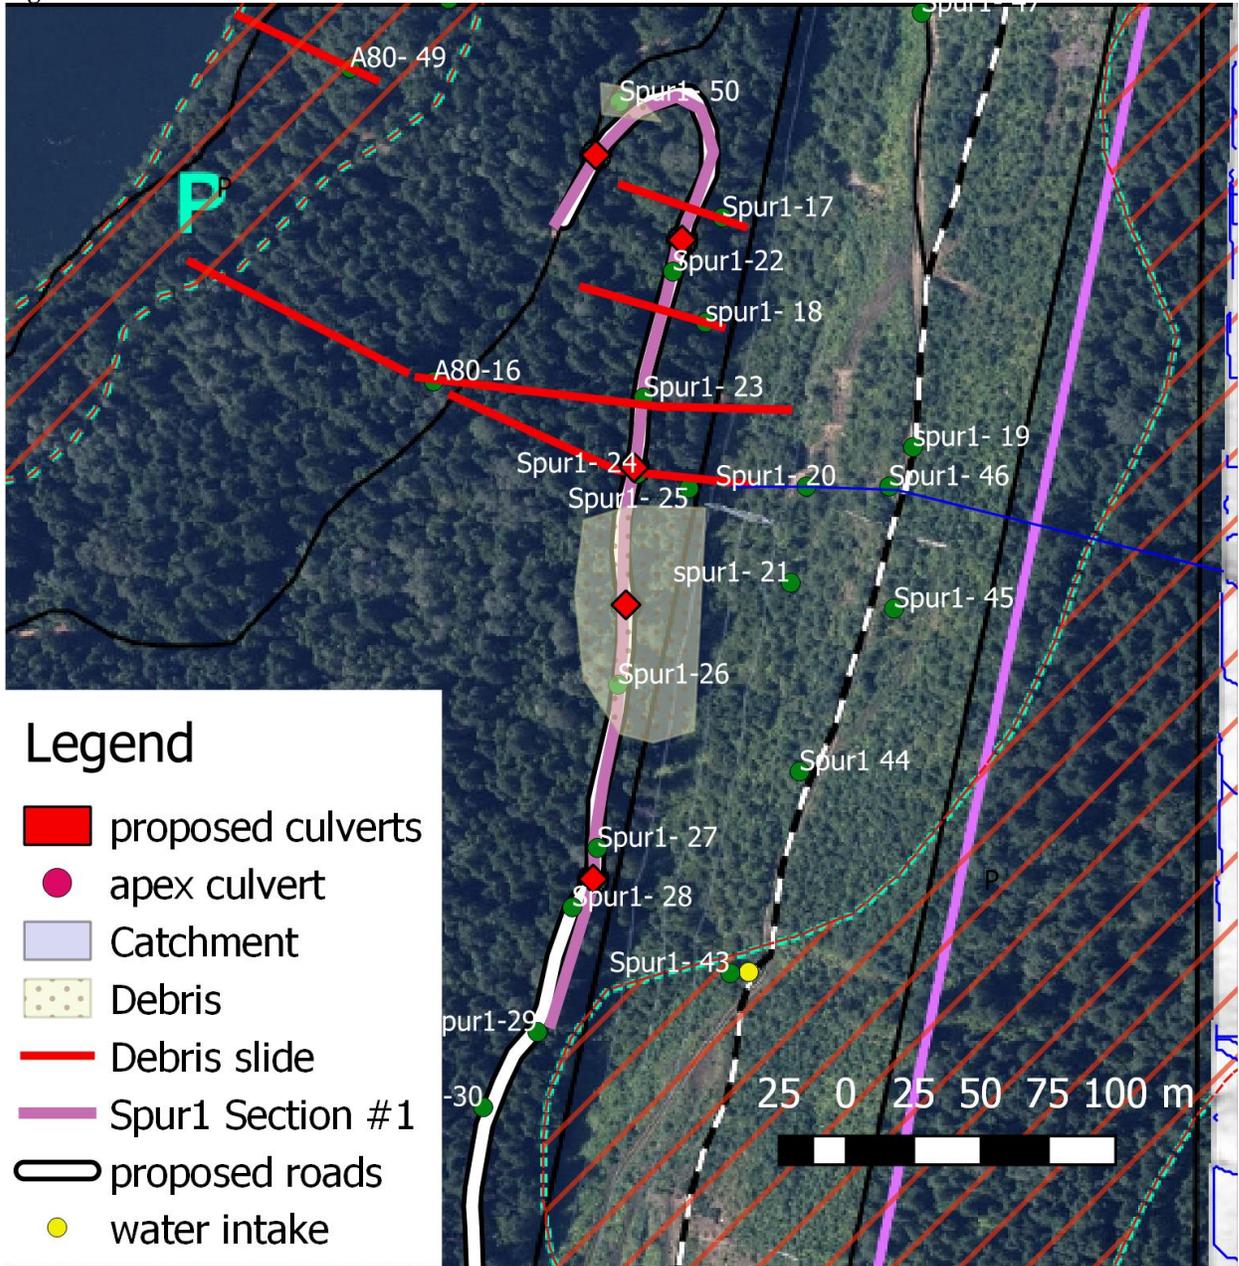
Figure 3

Section #1: (figure #3) This section of the road located below the Right of Way (ROW) for the powerline, there are at least four debris slide/flows crossing this section of the road. The slides range in age from 5 to 30 years old. Shallow gullies crossed by the road have hosted multiple debris flows. The initiation zones are between the powerline access road and the proposed road along a rock-controlled step just below the ROW. Access road, trails and push outs along the ROW likely concentrated and redirected slope drainage onto this slope. Recent cross-ditches along the road may have alleviated the likelihood of slides although some of the cross-ditches are too shallow to operate fully. In addition to the drainage diversions along the ROW, much of the headwater catchment of the stream that is upslope of the slides has been harvested (figure 4). The west aspect and elevation of the catchment may make it sensitive to harvesting which may have contributed to the instability, although the earliest slides pre-date the harvesting.

Section #1: This section of the road traverses the transport/deposition zone of upslope-initiated debris slides/flows. There is no private lands downslope, the powerline is upslope, and there are no intakes in the vicinity. There is a low likelihood of landslide initiation along this section of road. This section of the road is very low hazard.

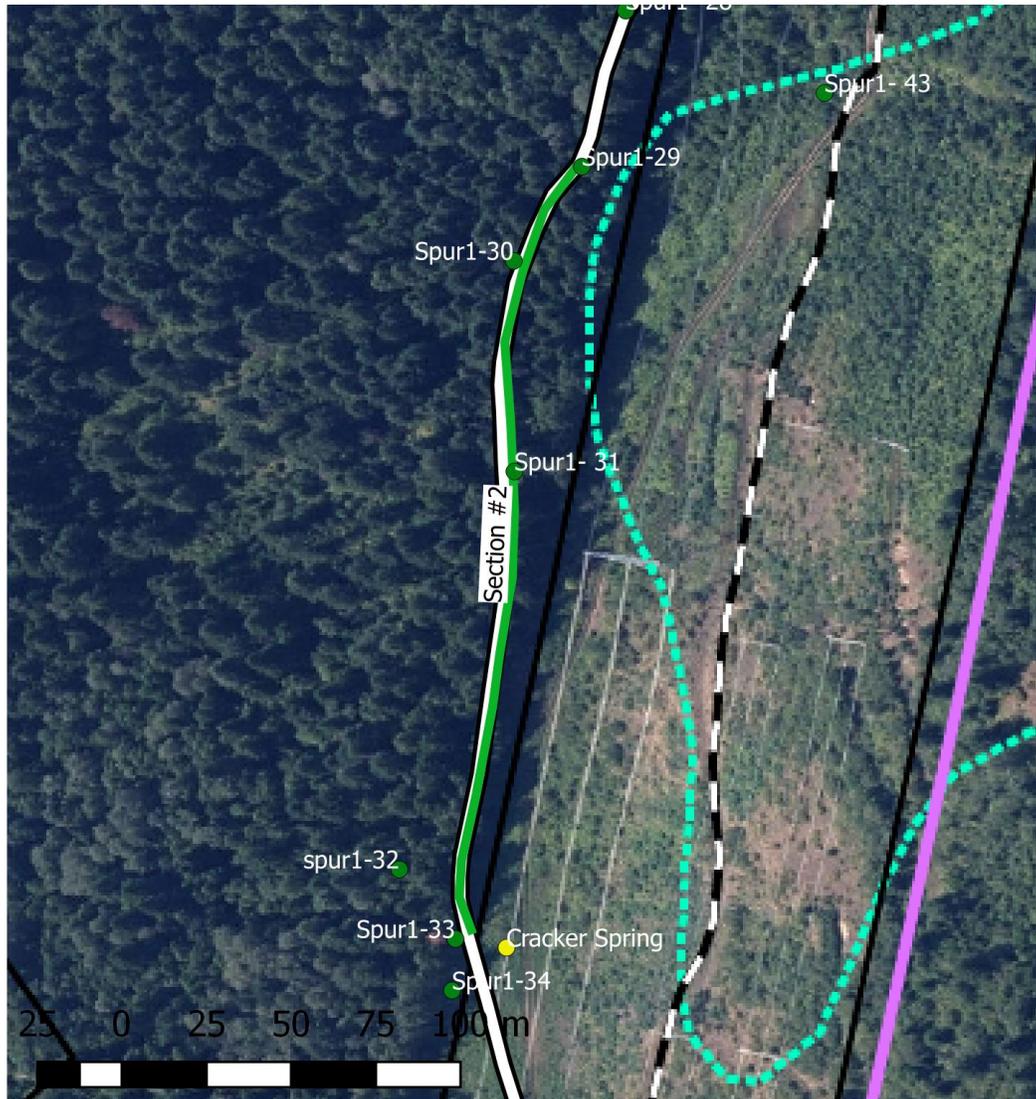
Figure 5

Section 2: (Figure #5) This section of the road angles up through rock-controlled benches up onto a broad terrace which at this location coincides with the ROW. The slope gradient does not exceed 65%. There is no evidence of instability.

No PoD's are mapped along this section, there is, however, a constructed pond along the powerline access road at station Spur 1-43 (Cracker Spring?),

Section #2: South end of section (Spur 1-32) treat as GOS, check drainage after road cut or match cross-drains to ROW locations. There is a low likelihood of landslide initiation. There is no private land downslope and the powerline is upslope. This section of the road is a very low hazard.

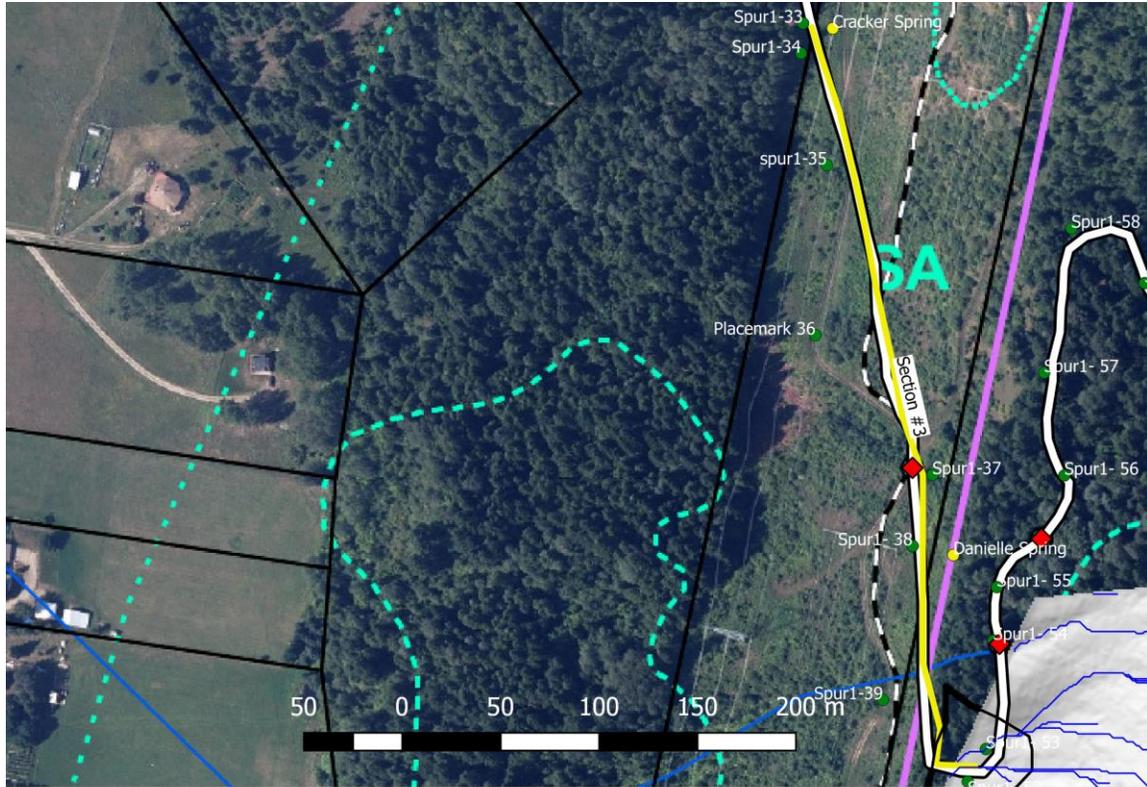
Figure 6

Section 3: This section of the road crosses the powerline ROW along a "terrace" top, crossing shallow gullies that feed deep ancient slumps and gullies. Most are dry with no evidence of erosion or flows crossing the existing road.

Cracker Spring is plotted at the north end of this section, but was not noted in the field. As stated previously, it may actually be located at station Spur 1-43. Danielle Spring is plotted along the southern end of this section but was not noted during the field review, it is likely that the spring location is actually upstream, water intake infrastructures was noted on the fan of Stream A.

Section #3: This section of the road is on a bench upslope of ancient slumps and deep gullies formed on a terrace scarp. This section is also downslope of the fan associated with stream A. Minor erosion of the ROW road and fill slope is the only indicator that flows from stream A cross the bench. Cracker Spring is mapped at the north end of this

section but was not noted in the field, it is likely that the location is mis plotted and is actually at station spur1-43. Danielle spring is mapped at the south end but is likely at site upstream of section 4. Neither springs should be impacted by this section of the road.

Private land is located downslope of portions of this section at the base of the terrace scarp which for most of the slope has short a $>20^\circ$ apron along the toe. A slide off the terrace scarp below the road section could impact the private land but is not likely to reach structures which are isolated from the slope by flat ground. There are no reported debris slides related to the RoW along this portion of slope. This section of the road should be treated as Gentle over Steep (GoS), drainage control is the primary management strategy. Drainage control as recommended in this report will result in a low likelihood of road related landslide initiation.

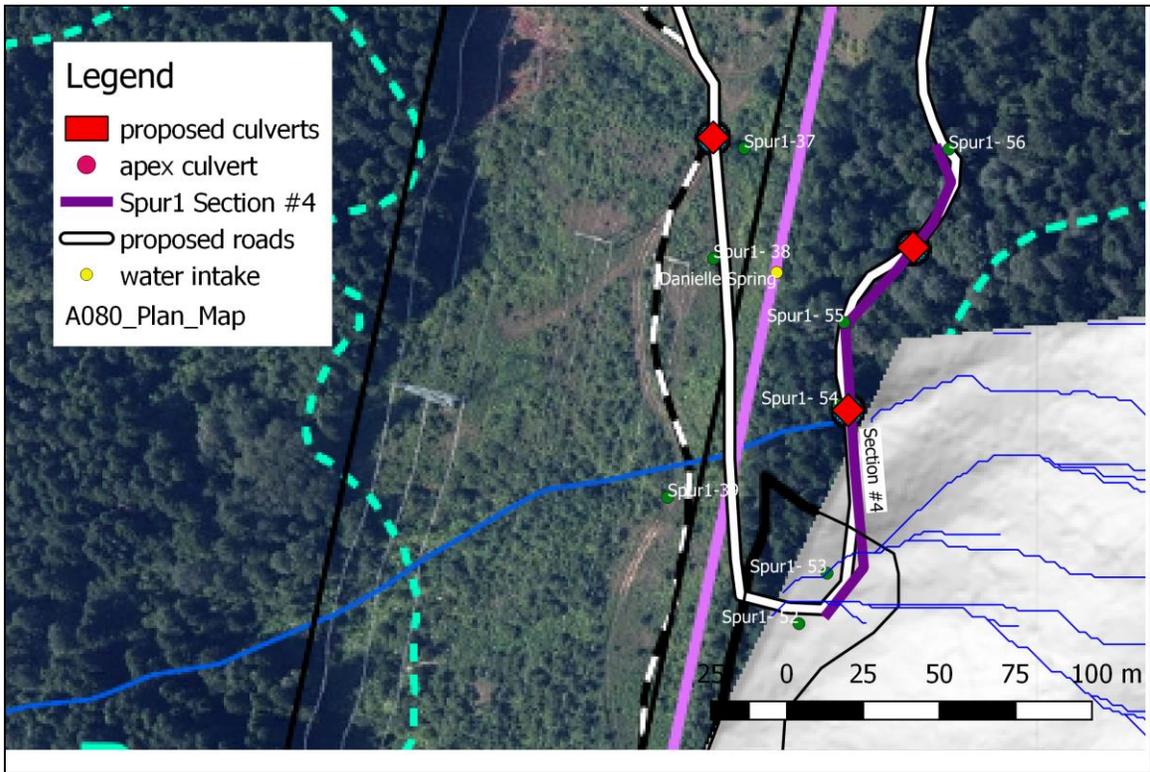
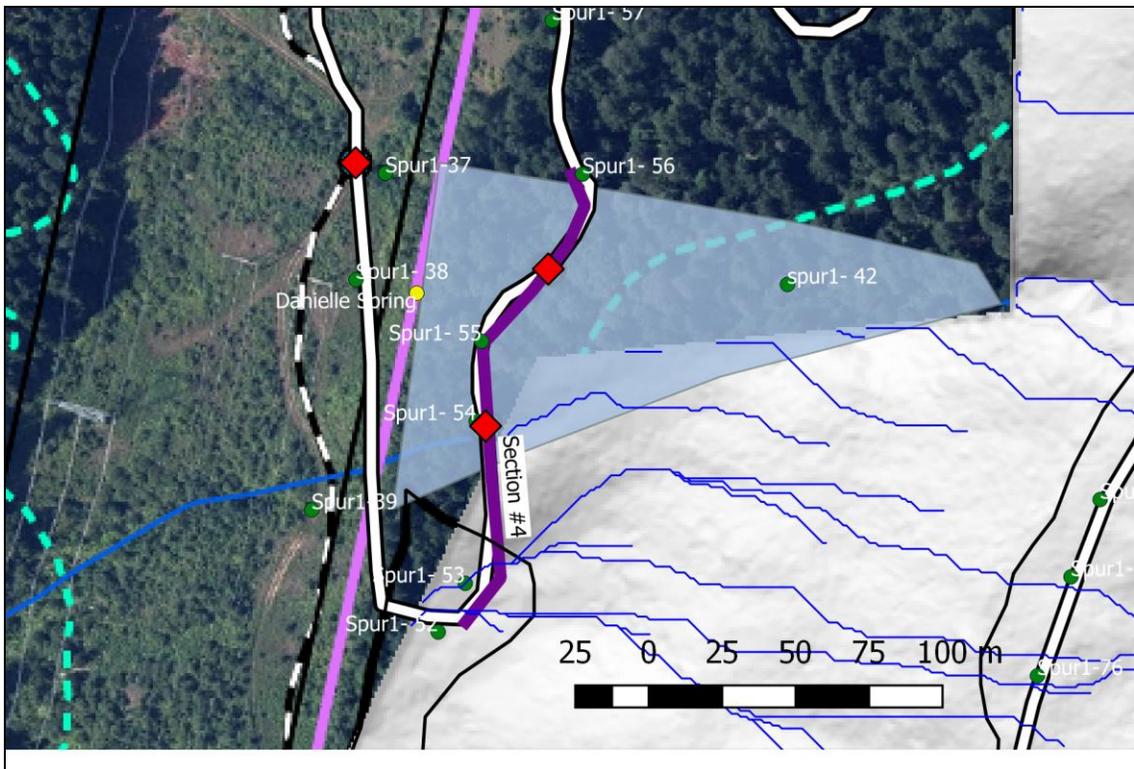
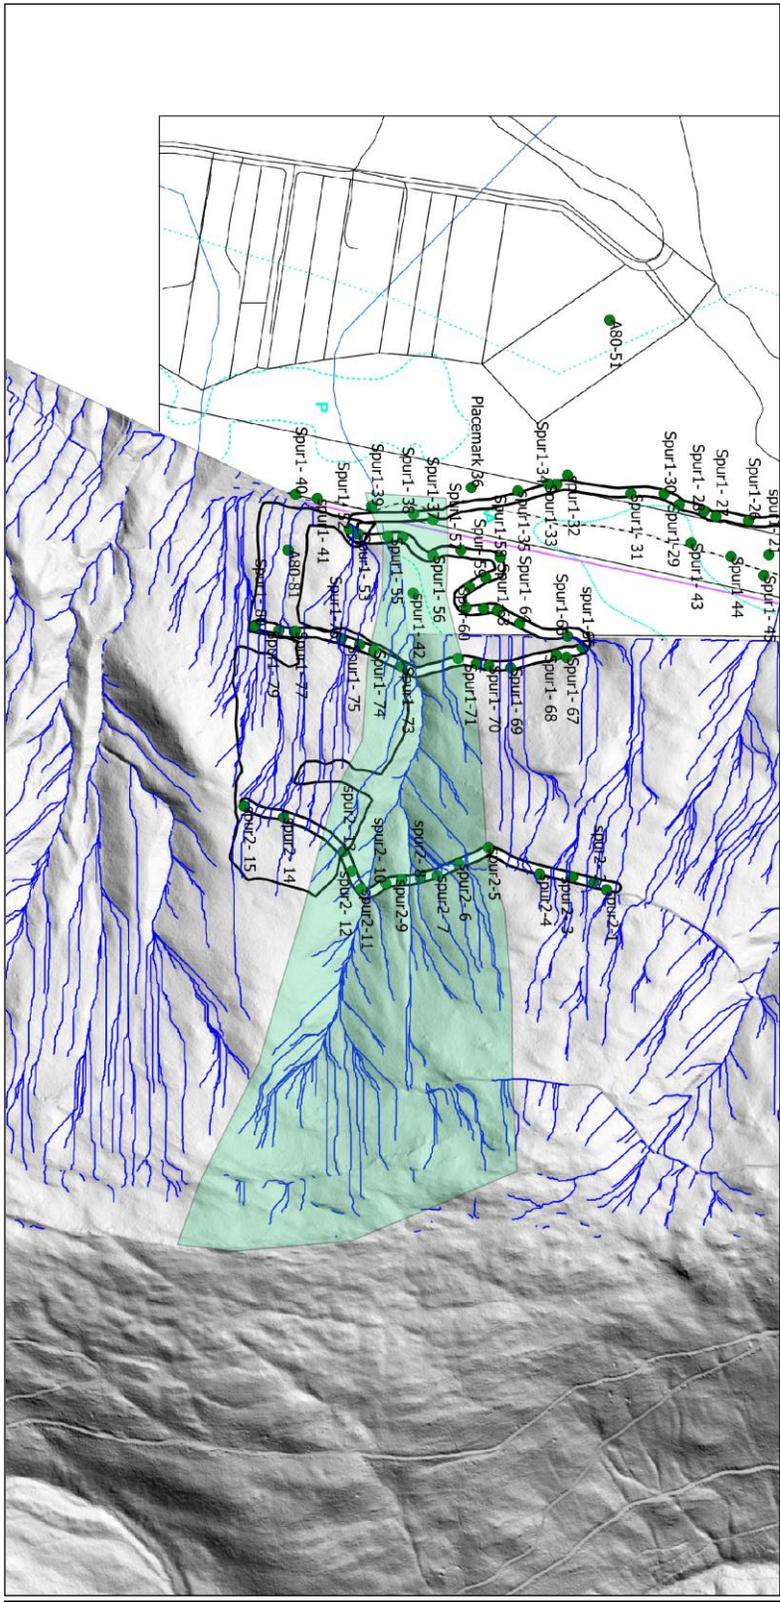
Section 4: This section crosses the fan and stream associated with Danielle Spring and Mountain Side Spring. Currently the active stream is near the north edge of the fan, inactive (or overflow) channels occur along the southern portion. Between the active and inactive channels there is widespread forest floor wash and small levees. Concrete boxes and pipes occur on the fan upslope up stream of this section between stations 1-55 and 1-56 and are possibly the Danielle Springs, and at station 1-42 (likely Mountain Side Spring). The source of the “springs” is likely hyporheic flows associated stream flowing through the “fan” (figure 8). The approximate surface area catchment is shown in figure 9.

Section #4: This section of road crosses the fan, inactive channels (overflow) and the active channel of stream A. This section of the road should be checked after construction to see if sub surface water is intercepted and diverted. If evidence is noted, than cross-drain structures should be constructed at those sites. After operational use (hauling) cross-ditches should be constructed at the inactive channel sites. The PoD’s are in the vicinity of this road section, the actual locations are not definitively known. It is assumed that Danielle Spring location is upslope of the road between sites 1-55 and 1-56 which is

upstream of this section and should not be impacted. This section of road is upslope of a broad bench on which the powerline is located and separates this section from the slope to private land. The main objective is drainage control, if the recommendations contained in this report are implemented there is a low likelihood of landslide initiation and a very low hazard to elements at risk.

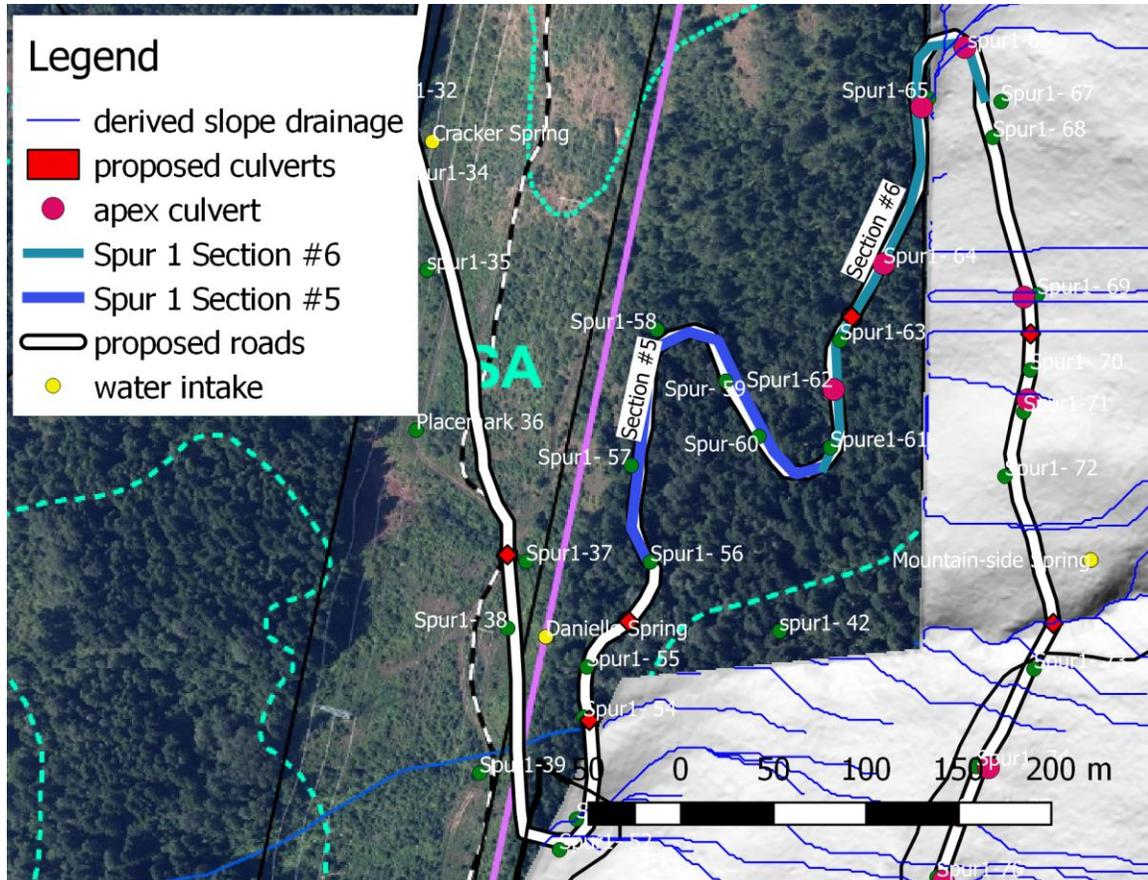
Figure 10

Section 5: (Figure 10) This section of the road crossed rock controlled benched terrain underlain by silty rubble and sandy gravel. There is no evidence of historic instability.

Section 6: (Figures 10 and 11) This section of the road crosses a 15 to 45% gradient silty rubble slope with swales. At station 1-64 there is a 50 to 75-year-old 0.7m high rubble levee, additional discontinuous levees and debris lobes are scattered across this fan like structure. The north end crosses, then heads up, a southerly trending rock draw, the switch is near the top of the draw, the road then crosses a short steep slope.

Section #5: This section of the road is located on moderate to gentle slopes upslope of a rock/gravel step to the powerline. There were no obvious surface flow features. After operational use (Hauling), cross-ditches should be constructed at swale locations. If these recommendations are followed there is a low likelihood of landslides and a very low hazard to elements at risk.

Section #6: There are several “swales” and rubble levees (50 to 75 years old) along the slope here. This is an erosion/deposition zone from upslope. There is a low likelihood of landslide initiation. This section of road is separated from the RoW and private land by low gradient slopes, there are no PoD’s in the vicinity. The hazard to elements at risk is very low.

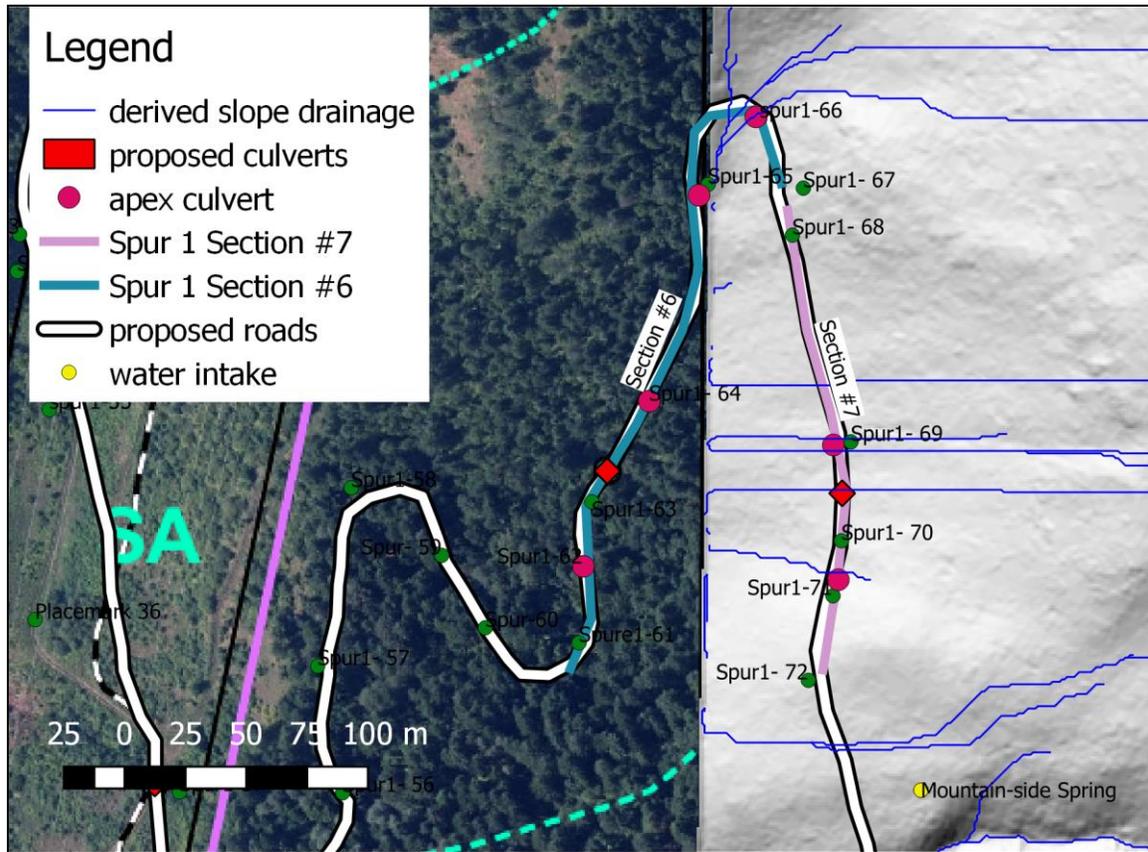
Figure 11

Section 7: (Figure 11) The road crosses a benched swaled slope (25 to 80%) underlain by veneer to blanket of silty angular rubble. At station 1-69 there is a 25 to 50-year-old 1m wide 0.5-meter-deep, stepped (rubble and blocks) eroded channel on a 65% slope. This channel is likely related to the levees noted at station 1-64.

Section #7: There are several swales and eroded channels that require culverts. There is a low likelihood of landslide initiation. Similar to section 6, there is a very low hazard.

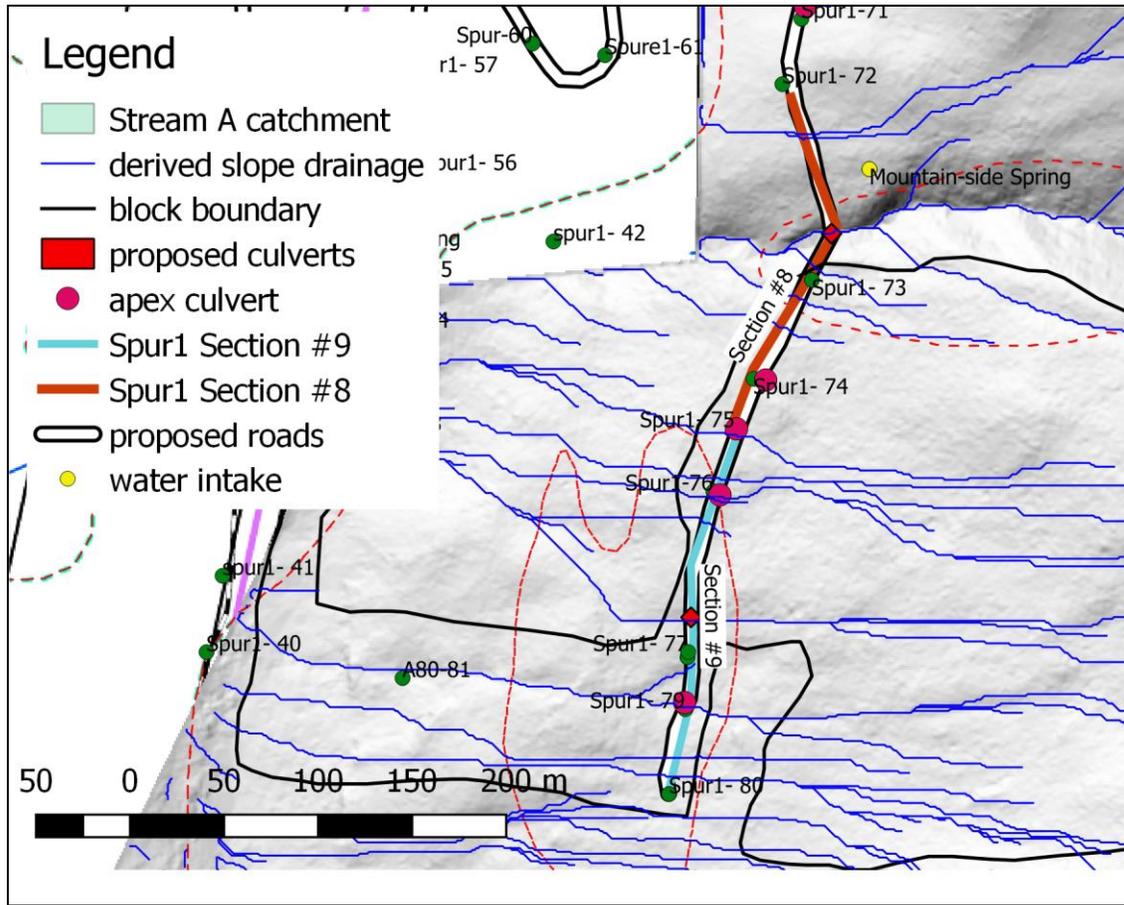
Figure 12

Section 8: (Figure 12) This portion of the road crosses the middle reach of Stream A, which is the likely source for the “springs”. Mountain side spring is plotted here but was not noted during the field assessment and is likely downstream at station 1-42. The approach to the stream crossing is on 45% or less gradient slope underlain by silty rubble. The rubble gully side slopes are 75 to 85% 3m high and directly connected to the creek (V-shaped). The stream gradient is 30%, there is no evidence of recent or historic debris flows.

Section 9: (Figure 12) The proposed road crosses 45% slope with small shallow swales underlain by blocky rubble and decomposed (silt) rock.

Section 8: This section includes the stream crossing. The side slopes are underlain by silty rubble with 75% angular fragments. The long-term angle of stability is likely around 45° (100%), rock is likely within 1m of the surface. The fill slope should be ~ 85% (1.2:1), the cut can be 1:1 in colluvium and 0.25:1 in rock. Use coarse fill (>0.25m) to fill through bottom of gully (bottom subgrade), to reduce sedimentation use coarse fill (>0.25cm) on the outside of the fill. If these recommendations are implemented, road construction will not significantly increase the low likelihood of landslide initiation. If a slide were to occur the slide would enter “Stream A” gully at less than 45°, the channel gradient here is 30%, it is likely that a slide would progress to a debris flow down the gully. Upstream of section 4, the gully discharges onto a broad fan with a gradient is less than 10°, a debris flow would terminate on the fan. There is a moderate likelihood the debris would reach the PoD’s on the fan. Although the vulnerability of the intakes on the

fan is unknown, it is likely that they would sustain significant damage. The debris flow would not impact the powerline or private land.

Section 9: This section of the road is underlain by blocky rubble and decomposed bedrock. After construction check swale locations to determine if water is intercepted, if water is noted, construct cross-ditches at those locations. The slope below this section is steep with rock steps to the bench where the powerline is located on the outer edge, the bench (~ 200 m > 15%) also separates the steep slope from private land. This section of road poses a very low hazard to elements at risk.

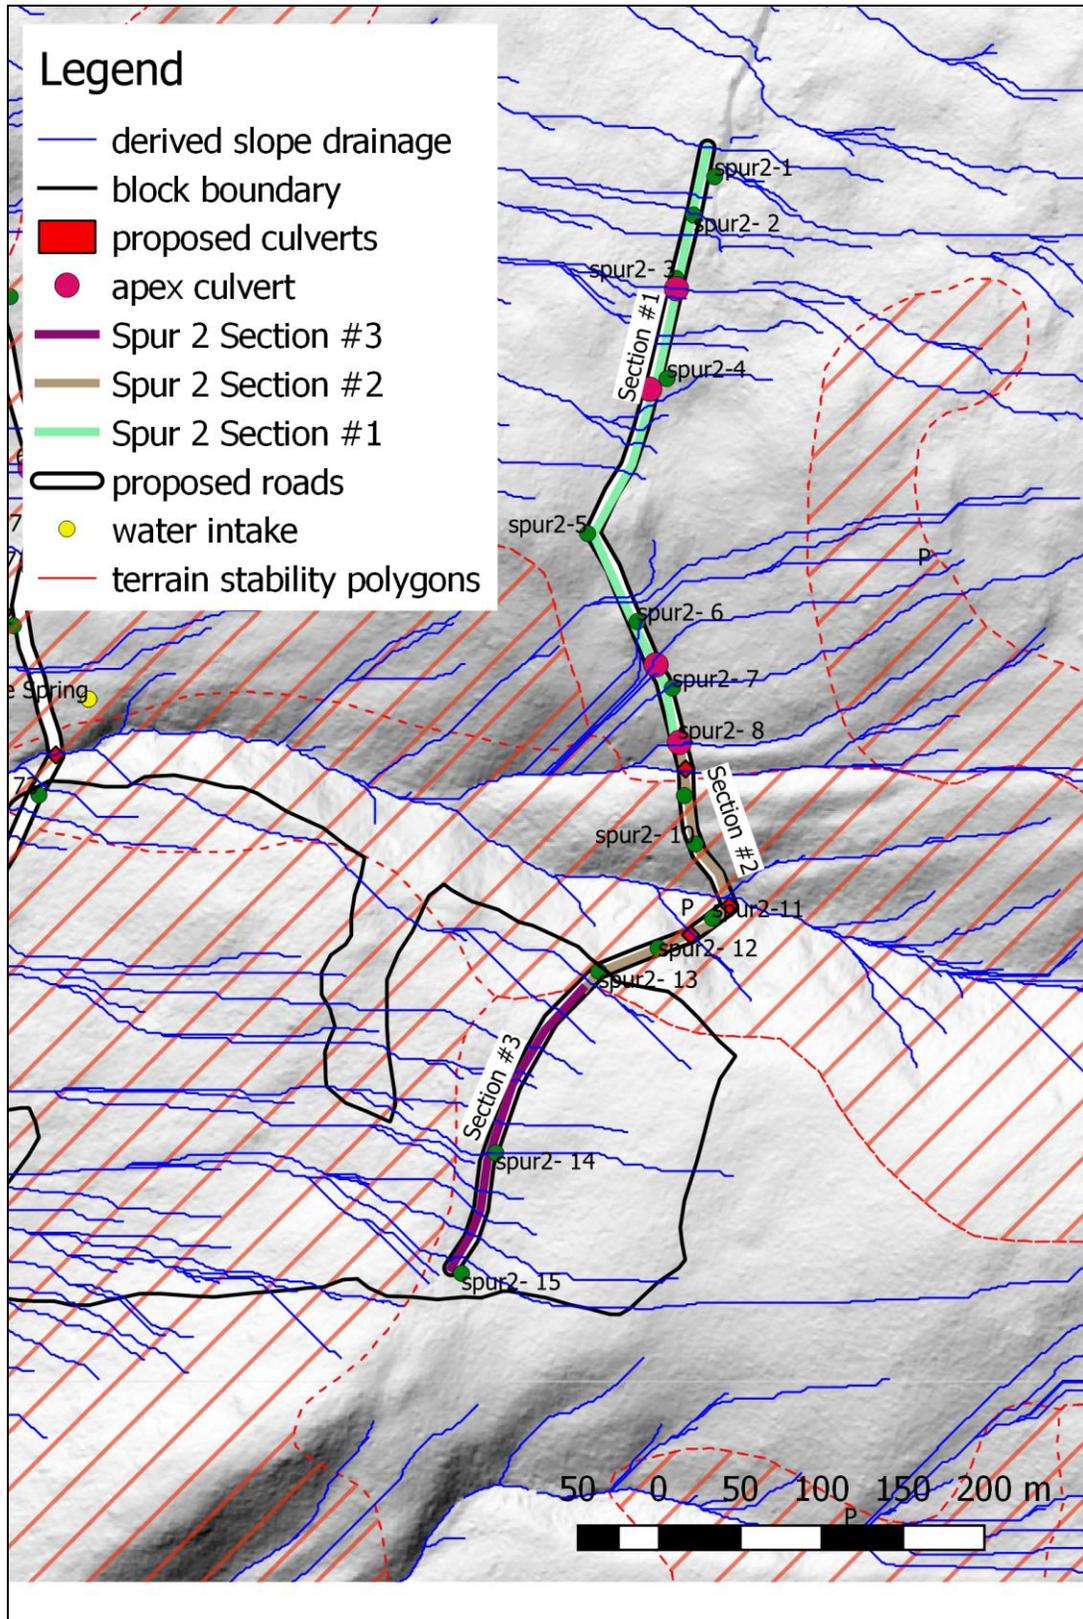
Figure 13

Section 1: (Figure 13) This section of the proposed road is predominately underlain by a veneer to blanket of non-cohesive, loose, silty- sandy angular gravel (USCS GM) with occasional short rock steps. The angular to subangular gravel content ranges from 60 to 80%. It is likely that much of the road will be excavated at least partially into rock. The slope traversed by the proposed road has a slope gradient of 50% to 65%. There is no evidence of historical instability.

Section 3: (Figure 13) The proposed road exits the gully system (block boundary) onto an open 55 to 65% gradient slope underlain by silty sandy gravel.

Section 1: The fill slope should be ~ 85% (1.2:1), the cut can be 1:1 in colluvium and 0.25:1 in rock. If these recommendations are implemented road construction will not significantly increase the low likelihood of landslide initiation. There are significant portions of the slope below this section that are less than 20°, landslides would pose a low hazard to elements assessed for risk.

Section 3: The proposed road exits the gully system (block boundary) onto an open 55 to 65% gradient slope underlain by silty sandy gravel. There are significant slope sections of less than 20° downslope, there is a very low hazard.

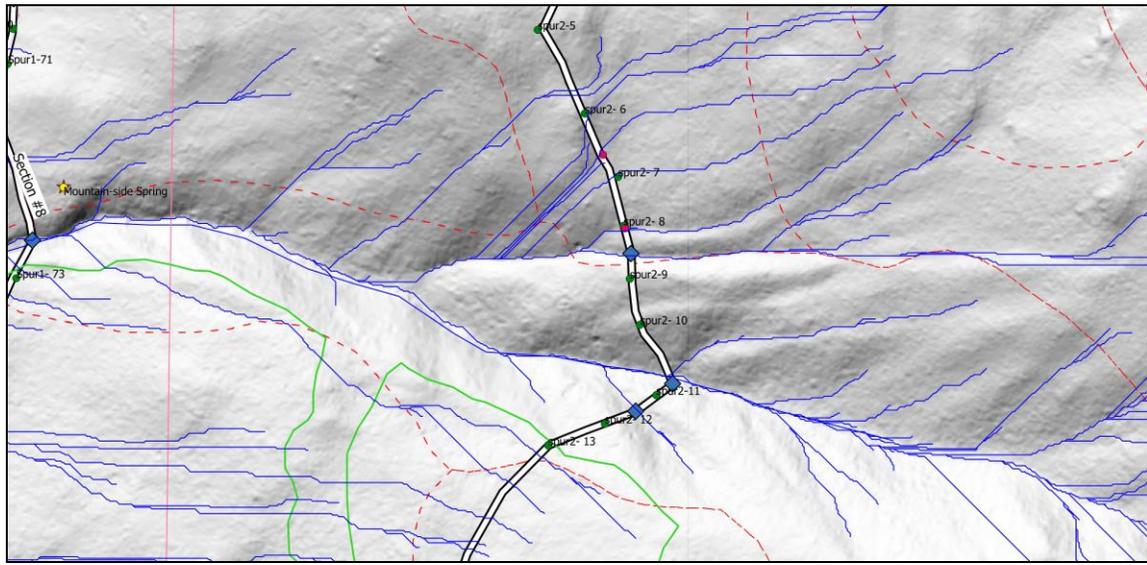
Figure 14

(Figures 13 and 14) The road crosses two main gullies and several secondary swales and associated interfluves. This results in a long section of road within the “gully system” crossing through interfluves and gullies.

Just prior to the northern gully, on 65% gradient slope, the proposed road crosses a small open swale (site spur 2-8) with rock exposed at the bottom. There is no evidence of recent surface flows. Just “downstream” the slope gradient increases to 90%.

The northern gully (spur2-9) has 3m high 85% gradient side slope underlain by silty sandy rubble. The gully gradient is 60%, there is no obvious stream channel and no evidence of debris flows.

The road then crosses an 85% gradient, wide interfluve (with a broad swale), soil pits give 95% coarse fragments, (rock is likely close).

The road then crosses just upstream of the junction of the main gully and a secondary swale just to the south. The gully side slopes are 85 to 90% and 3 to 4 meters high. The south side slope is underlain by silty sandy well graded sub angular gravel. The gully has a wide flat bottom, the gradient is 55% and there is no trim line. Rock is exposed near the top of the south side slope. The proposed road then crosses the nose of an interfluve (-

85%/+65%) underlain by subangular gravel and into the secondary swale then onto a 70% gradient slope underlain by sandy silty colluvium.

For the gully crossing Use $\frac{3}{4}$ bench to enter the “north” gully, push excess forward to fill gully. Push through interfluvium to fill second main gully, $\frac{3}{4}$ bench out of gully, push through interfluvium to fill secondary swale, use hoe to key fill into slope. If these recommendations are followed road construction will not significantly increase the low likelihood of landslide initiation. If a slide did occur it would enter the gully system at less than 45°, the stream gradient exceeds 10°, debris slides would transition into debris flows down the gully system. The debris flow would likely reach the lower fan below the upper lift of Spur 1. The Water PoD's are located on the lower fan and may be damaged. The debris flow would likely terminate on the fan well above the power lines and private property.
