Detailed Terrain Stability Field Review

Proposed Harvesting and Road Construction
For Wildfire Interface Control in the Selous
Creek, Schesnuk Creek and Ward Creek
Areas(CP K079)
for
Kalesnikoff Lumber Company Ltd.

W. Halleran P. Geo, L.Eng.

01/08/2020

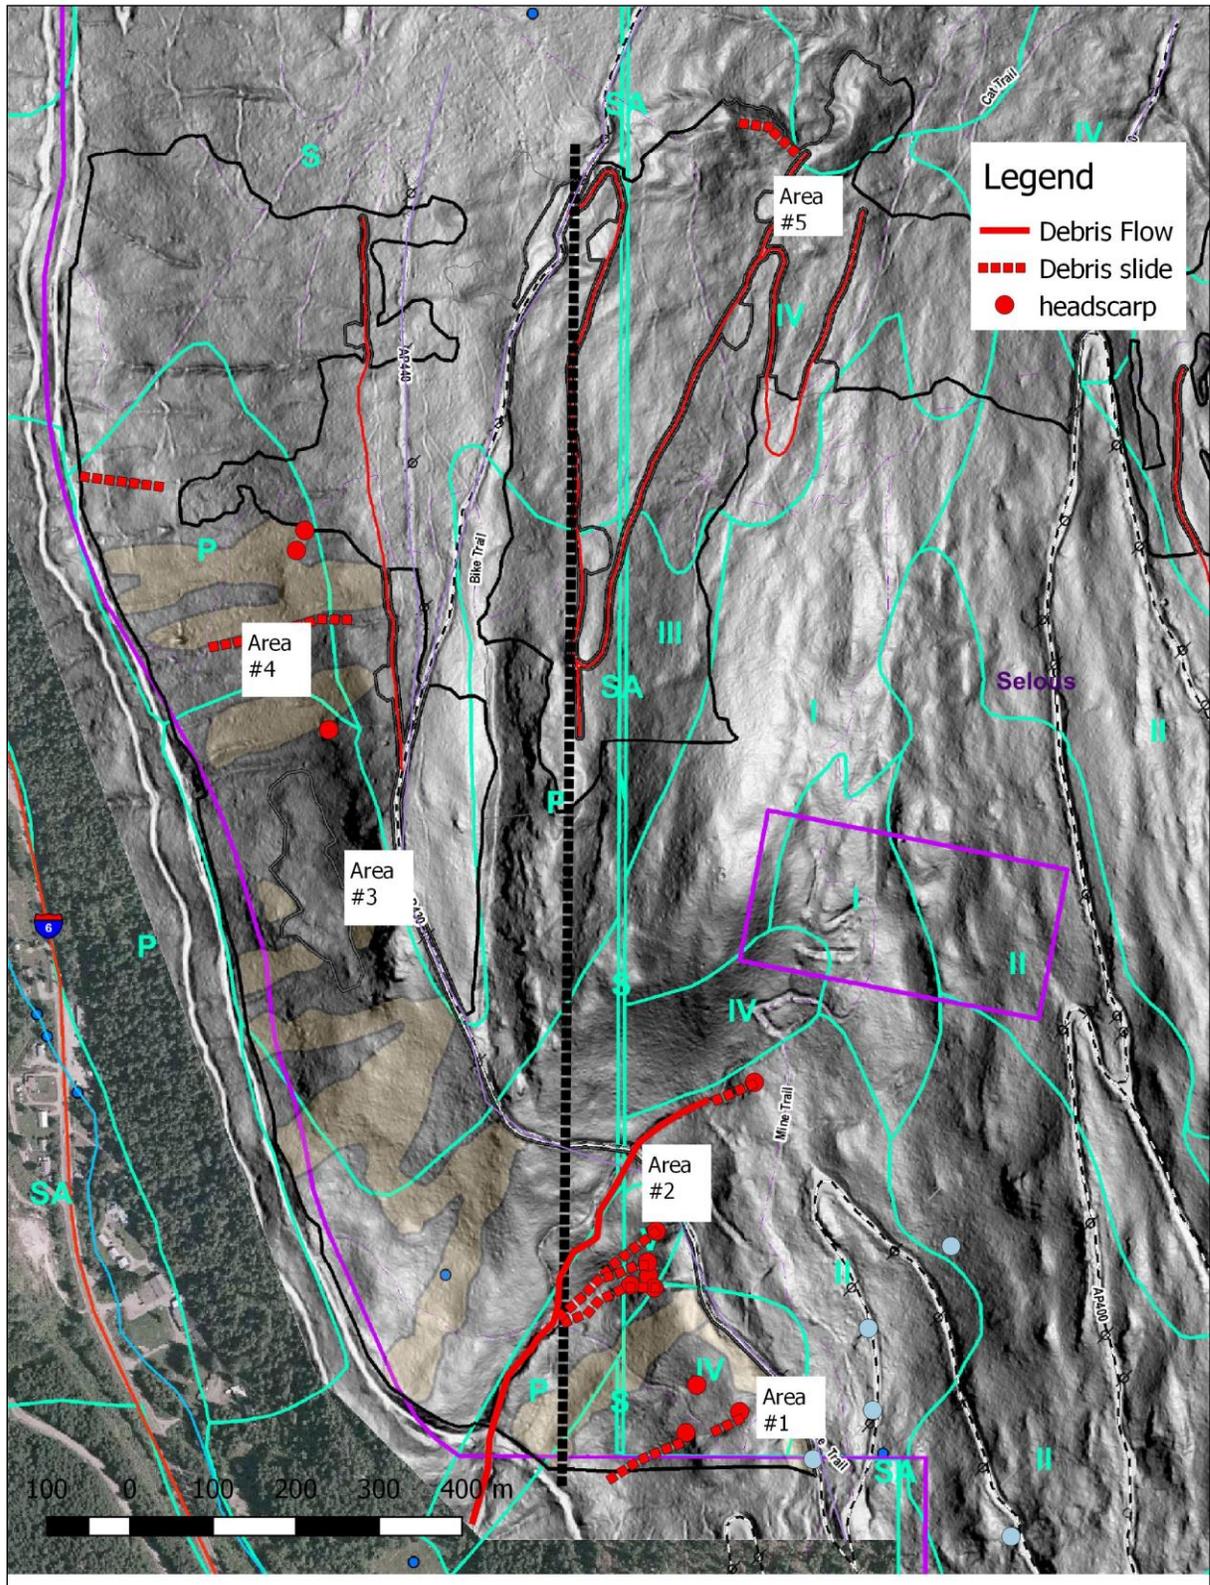
Figure 6

The observed instability is grouped into five areas as shown in figure 6.

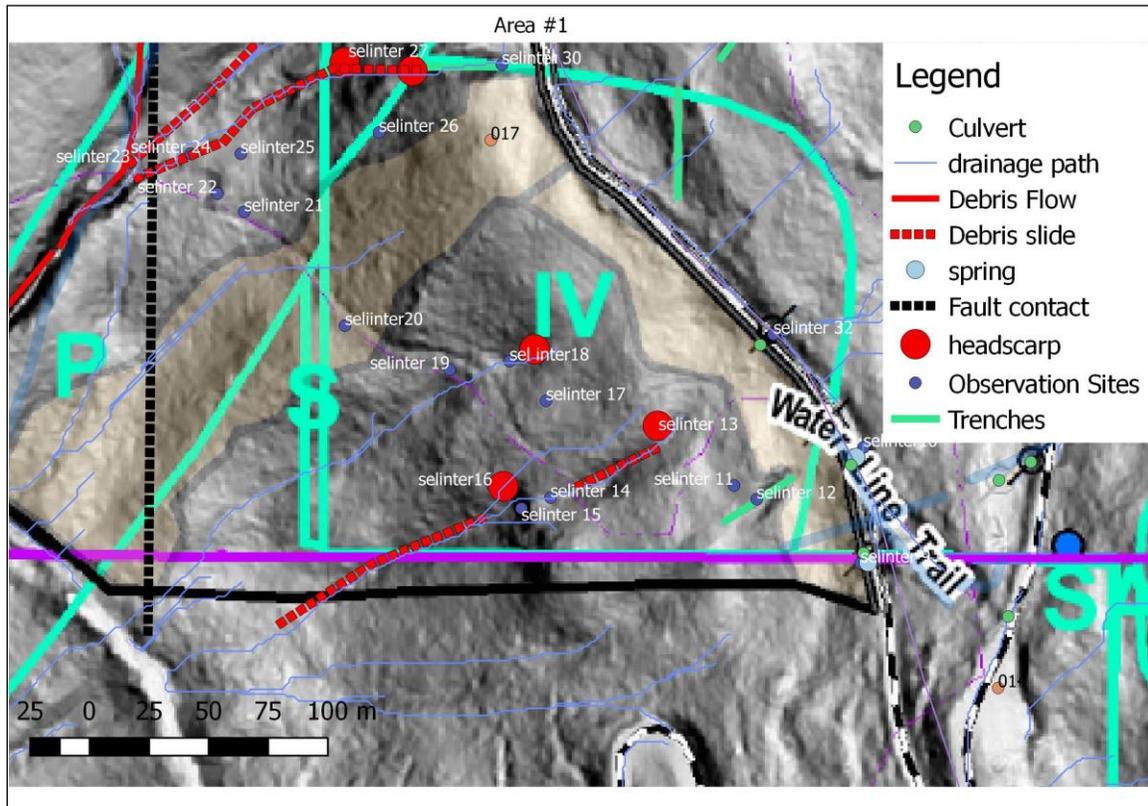
Figure 7

Area #1: Stations 13, 16, and 18; Figure #7.

A small subdued headscarp (station 13) feeds into an erosional gully (V shaped). There are large vets in the bottom of the gully and no trim lines suggesting >500 yrs. The surficial material is loose sandy sub angular gravel. Further down the gully at station 14 there is evidence of minor old erosion (50-100 yrs.). The gully becomes unconfined at a small old sediment wedge of brown sandy soil (likely from the 50-100 erosion). The channel diverts around the wedge onto steeper slopes below. The steeper slope becomes a small rock step (station 15). At the base of the rock step there is an ancient shallow debris slide (>500yrs). The area was stable through the last fire, more recent erosion and deposition may be associated with mining activity or surface erosion in response to the last fire.

Further north along the slope there is a similar headscarp (Station 18). This scarp has mixed soil horizons suggesting there was some activity about 100 yrs. ago. There is a 3m wide bench below the scarp, upslope of steeper slopes and mining trails with no evidence of a debris slide or flow, suggesting the mixed soil on the scarp was a result of shallow sloughing that did not progress to a debris slide.

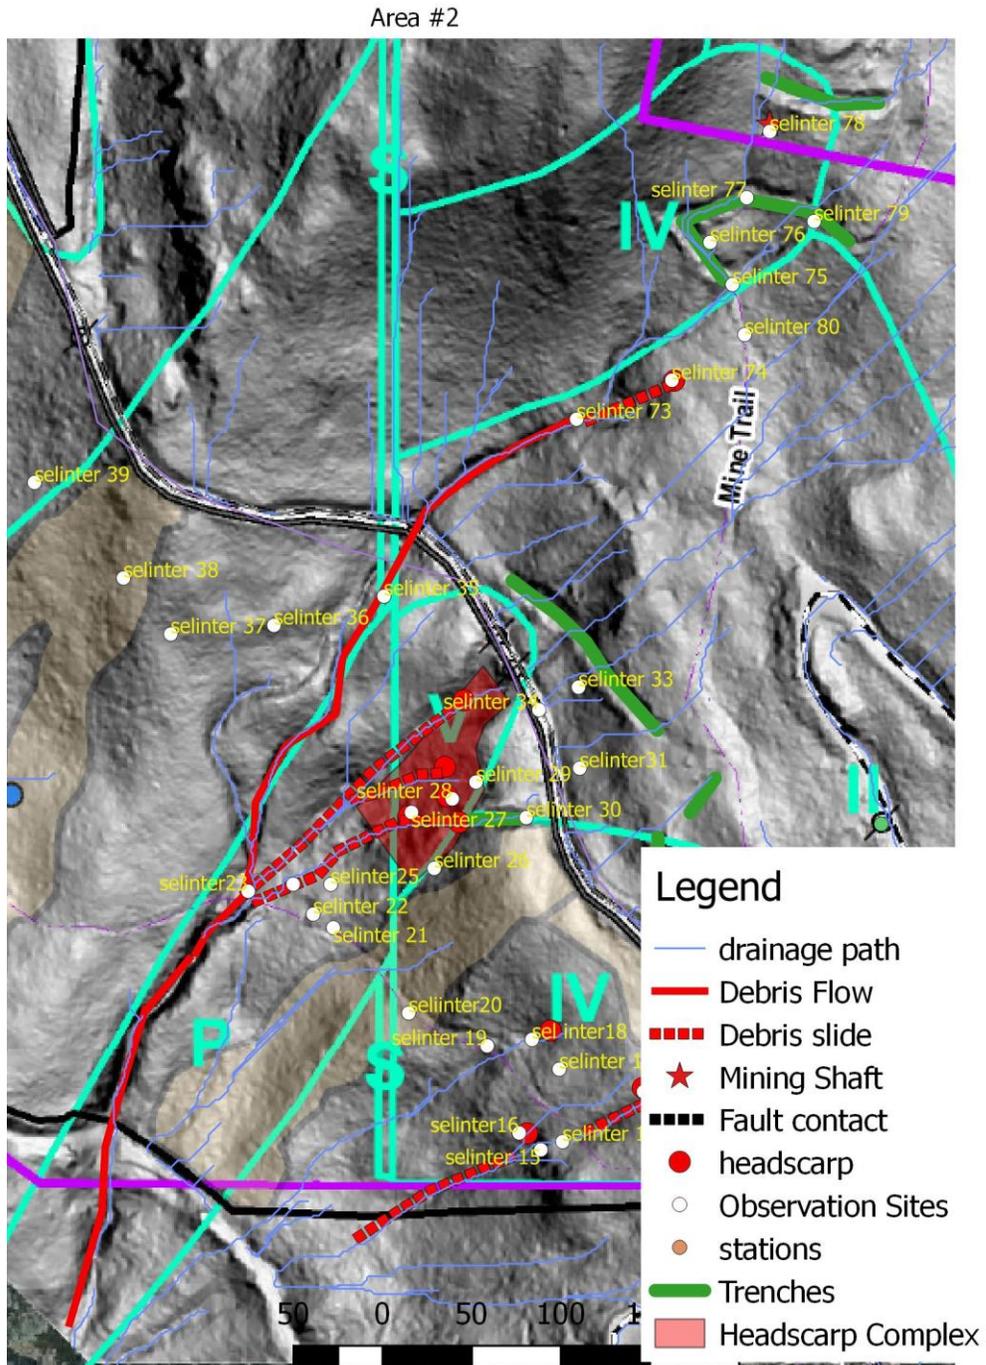
Figure 8

Area #2 Schesnuk Creek Area; Figure 8:

There are two areas of recurring debris slides, the slides enter Schesnuk creek (>20% gradient) at less than 30°, triggering debris flows down the creek. There were major debris flow events in 1997 and 2012, down Schesnuk Creek. A debris slide below Spur 430 triggered the 1997 event, a debris slide upslope of the spur contributed to the 2012 event. Both events are associated with late snow packs. The debris flows impacted downslope resources including the trestle bridge (rail trail), private land, water intakes and Cottonwood creek.

In 1997 heavy rainfall (rain on snow) was the primary trigger. In 1997 a debris slide initiated directly below mineral exploration working. The slide and antecedent conditions have been described previously. This slide occurred before the present existing haul road was constructed and upslope harvesting completed.

An earlier inspection of this slide is summarised in the review section. During this review it was noted that part way down the main slide scarp a spring flows out the base of weathered diorite. The slide scarp is complex with multiple crowns and scarps, 22-year-old trees in a scar and recent debris piled against trees indicated active and ongoing instability. Although the debris flow down Schesnuk Creek appears to post-date the road assessment, it is apparent that debris slides have been going on for some time. At Station 26 there are scattered old to ancient small debris slides in the forest adjacent to the active slide scarp, the slope gradient is 90% and is underlain by sandy to silty gravel.

Investigation of the main slide scarp associated with the 2012 event, found that there is a draw which ends at a 2.5m high rock face above the scarp, upslope of the rock face there is a broad wet area. A 2m wide boulder swale sweeps in from the south, just to the south there is a 5m deep trench that discharges directly into the scarp area. It is likely that the “wet bench” was drained by the deep trench triggering the original debris slide on the south side of the recent unstable area. Upslope of the bench, a debris cone deposited on the old mining road (1983) below a trench (or draw) indicates mass wasting from upslope, this is directly below the “spring” noted previously flowing out of the tailings pile. It was noted that there is water pooled in the Lizzie adit which has been partially blocked by a bulldozer push. It is possible that at times water flows out of the adit, down the trench (or draw) and is directed onto the wet bench (and subsequently to the scarp) by a shallow cross-ditch. Debris slides entering Schesnuk Creek channel trigger debris flows when there is enough water in the creek to mobilise the debris. Although there are older debris slides, there was no evidence of debris flows prior to 2008, suggesting increased slope drainage in Schesnuk Creek may be at least partially responsible for the transition from debris slide to debris flow.

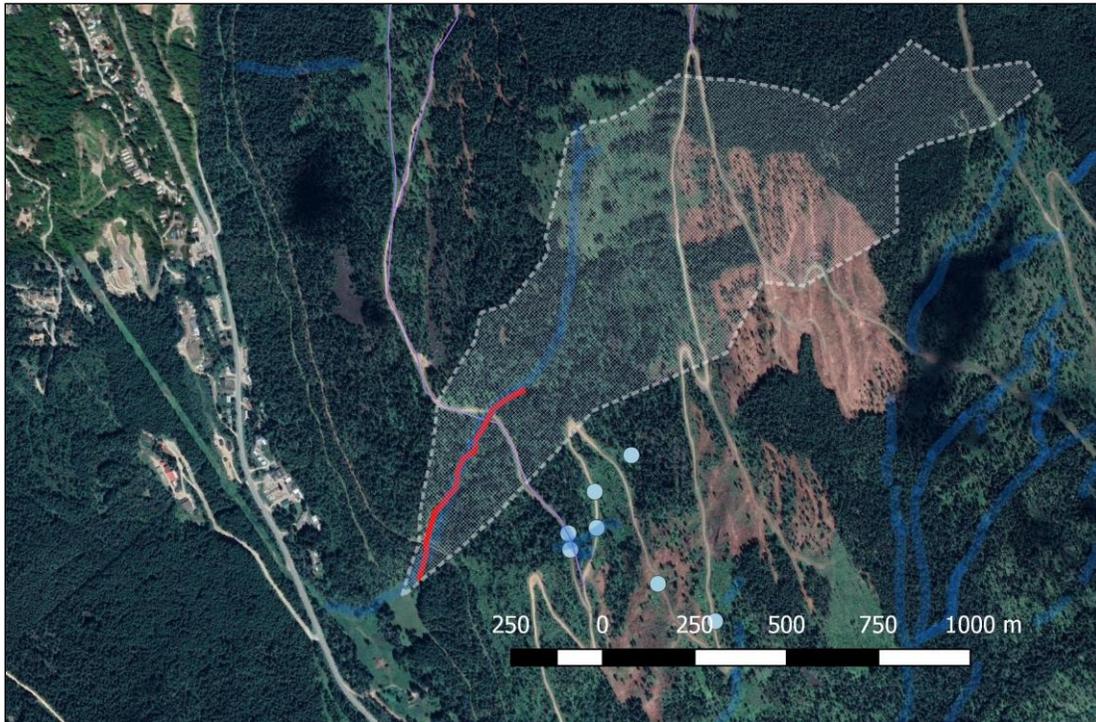
Figure 9 illustrates the development in Schesnuik Creek Catchment.

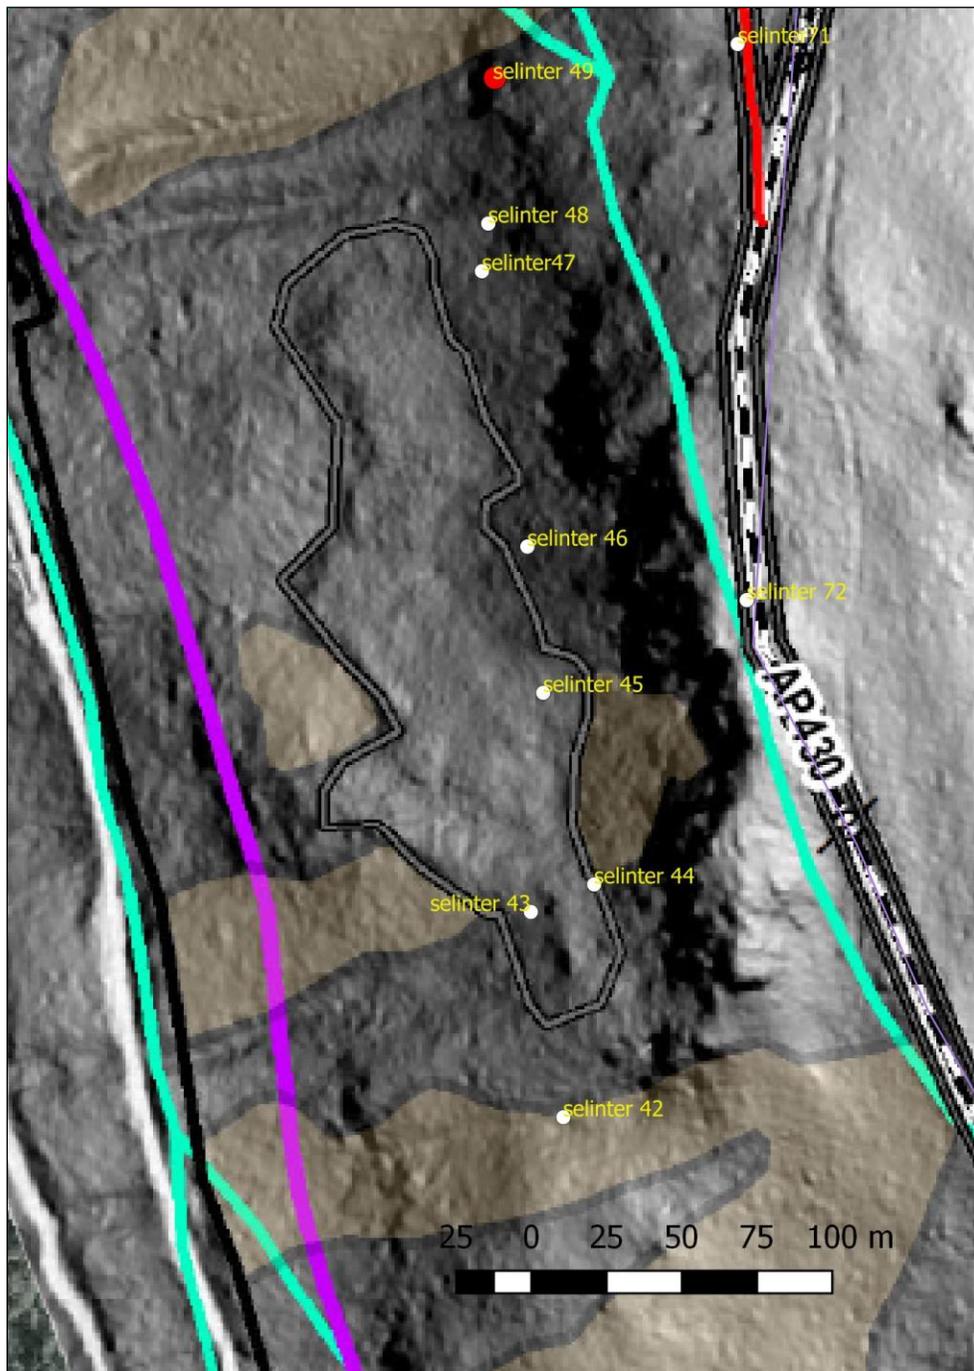
Figure 10

Area #3: Stations 42 to 47; Figure 10:

Rockfall/topple occurs along the bluff faces. Individual blocks currently are stopping along the upper to mid portion of the blocky talus slopes below the bluffs. The blocky talus slopes average 65% and are rough and loose. Bluffs are up to 20m high.

These events are ongoing but isolated, likely triggered by frost heaves and tree churns.

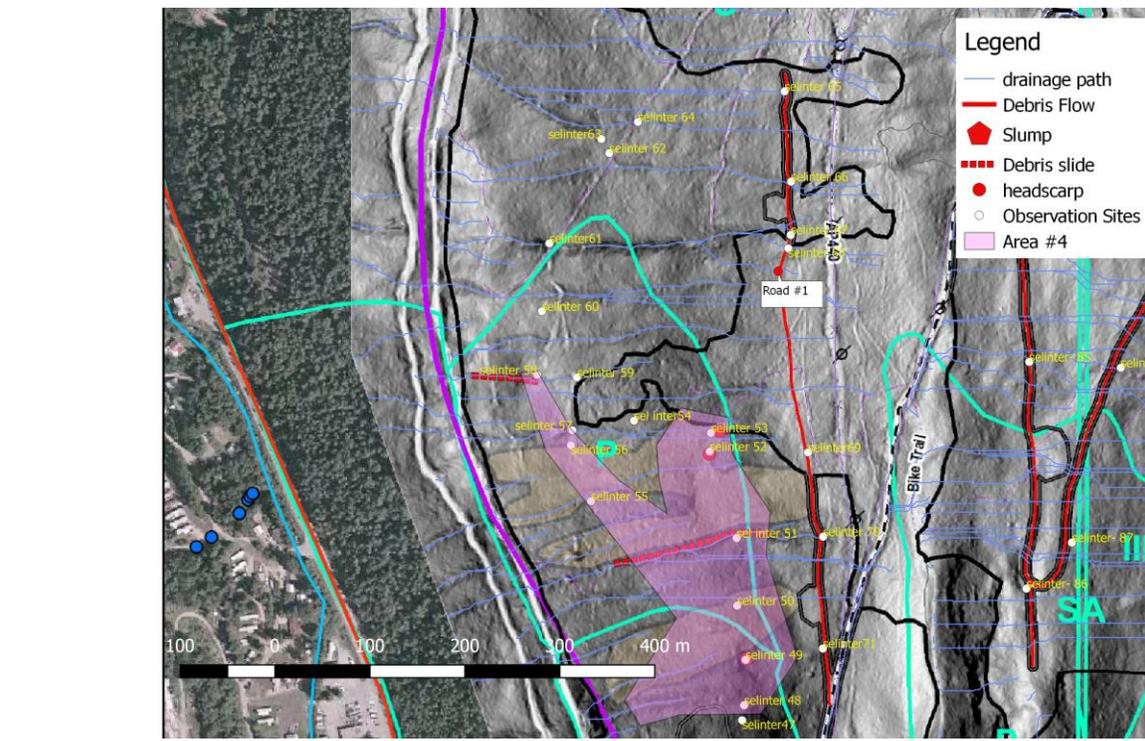
Figure 11

Area #4: Stations 48 to 59; figure 11:

This area is underlain by at least 2m of variably sandy (from 30 to 100% sand) loose gravel. Several swales (2m deep floored in rock) occur across the slope. These swales are

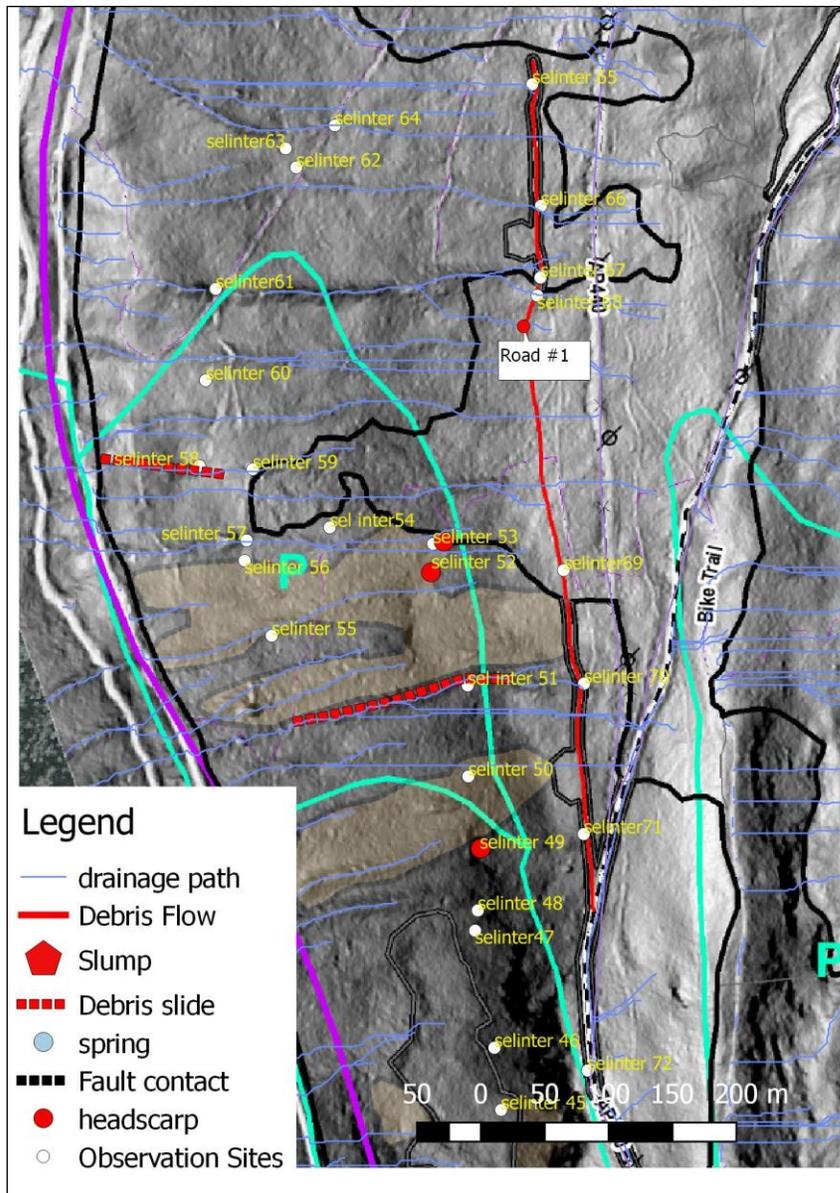
Figure 13

Road #1 (Stations 65-71, Figure 13).

The POC of the road is off Spur 430. The proposed road is situated downslope of spurs 430 and 440, spur 440 has been deactivated. Old mining trails and roads are common on this slope. The slope traversed by the road has a gradient less than 55% with no evidence of instability. Proposed culvert locations are well situated, additional culverts were marked in areas of minor flows and old wash. The proposed road is partially upslope of Area #3 and is upslope of Area #4. There are no slides associated with existing Spurs 440 and 430.

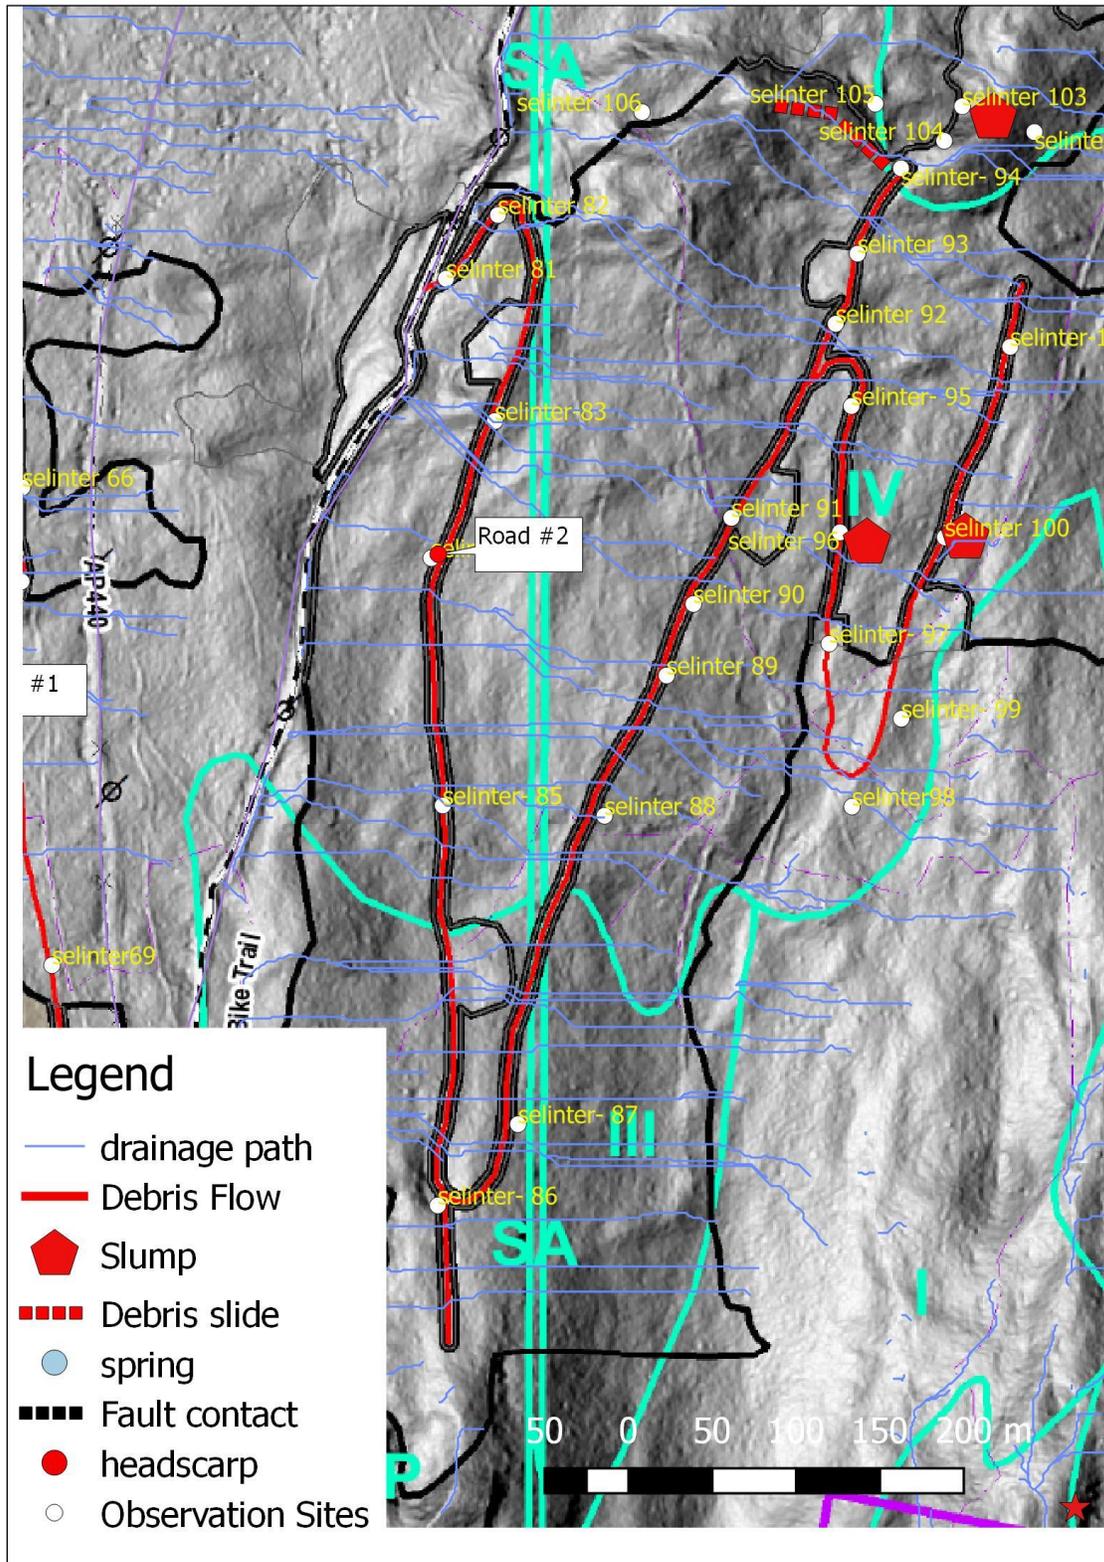
Figure 14

Road #2 (stations 81-101) Figure 14:

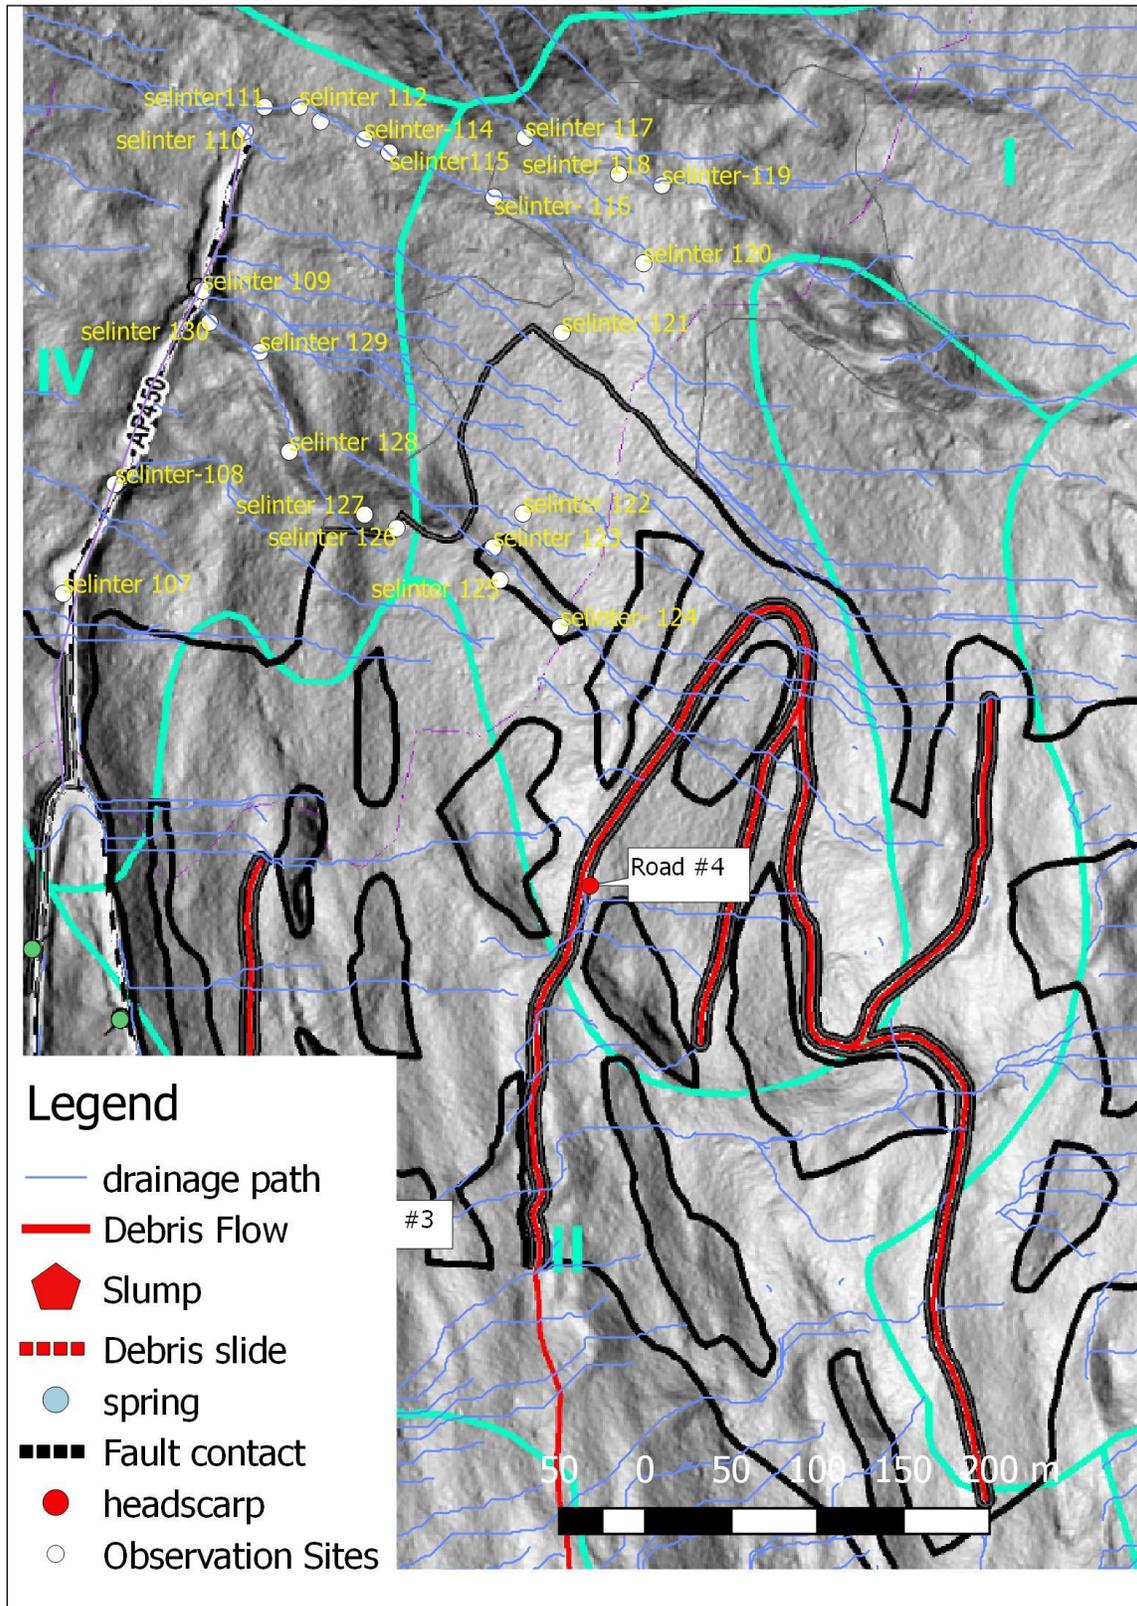
Figure 15

Road #4: (Stations 107 to 130) Figure 15:

Road #4 is potentially partially within Ward Creek Catchment. The field assessment was to determine if there was a direct linkage to Ward Creek and if there were indicators of instability within the proposed development area that could impact Ward Creek. The surficial material around Ward creek has a high sand component. The proposed development is set back from the steep side slopes to Ward Creek. There is a small seasonal stream (stations 111-116) that parallels Ward Creek, this channel forms the boundary of the existing blocks and was surveyed in as part of the CP 29 stream assessments. There are old sand levees and recent scour within, and adjacent to, this channel. The most recent levees are likely related to the last fire, the recent scour is likely related to recent increased slope drainage (likely correlates to the recent slides).

There is a permanent spring within a draw crossed by spur 450 downslope of the proposed road. The spring (station 130) occurs just “upstream” of the road crossing, the draw was inspected within and downslope of the proposed development to the road crossing (Stations 123 -130). At station 123 the draw is a dry sandy rubble draw, upslope at station 124 the draw is a swale and is crossed by a mining trail. The draw (s) is dry with no evidence of surface flows until around 129 where water is pooling in tree churns in the broad draw bottom, at station 130 there is a strong spring out of the south side slope of the draw. The flow is carried across the road in a culvert and discharged onto what appears to be a broad scarp, the stream disperses across the slope, there are no obvious draws or swales downslope in the existing cut block.
