APEX GEOSCIENCE CONSULTANTS LTD.

Detailed Terrain Stability Field Review

Spur 1 and 2 and associated Block A080
Glade/Rover Area
For
Kalesnikoff Lumber Company Ltd.

09/20/2019

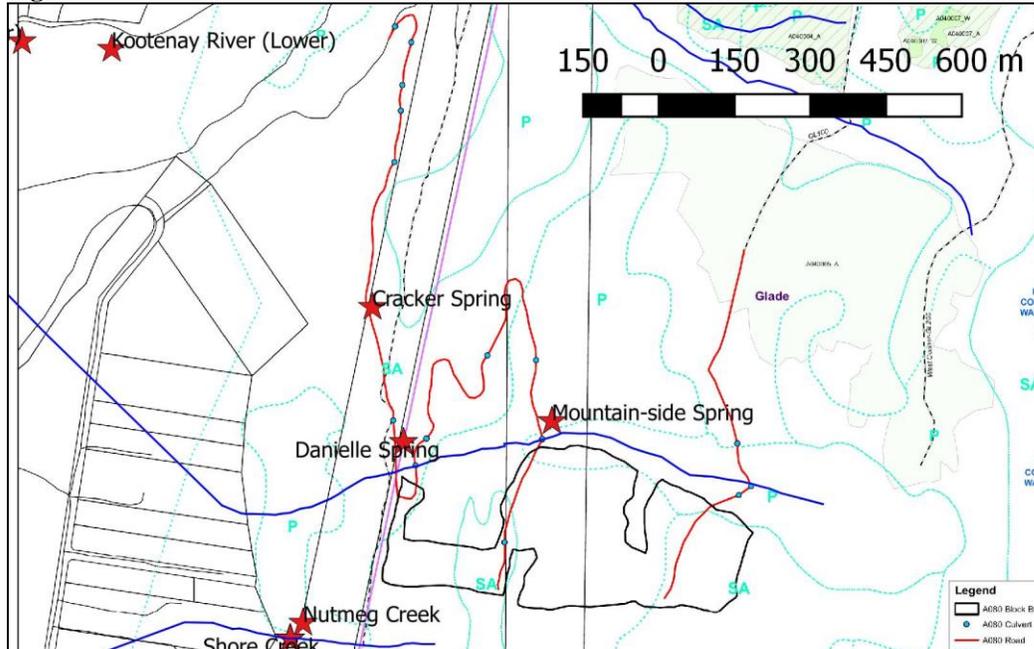
Figure 1

The proposed block, spurs, terrain polygons and pods are shown on Figure #1. The locations of the Springs marked on this map are downloaded from the government database, field observations indicate the locations may be misplotted. Field notes and observations are tabulated in Appendix I and shown on figure 11 in back.

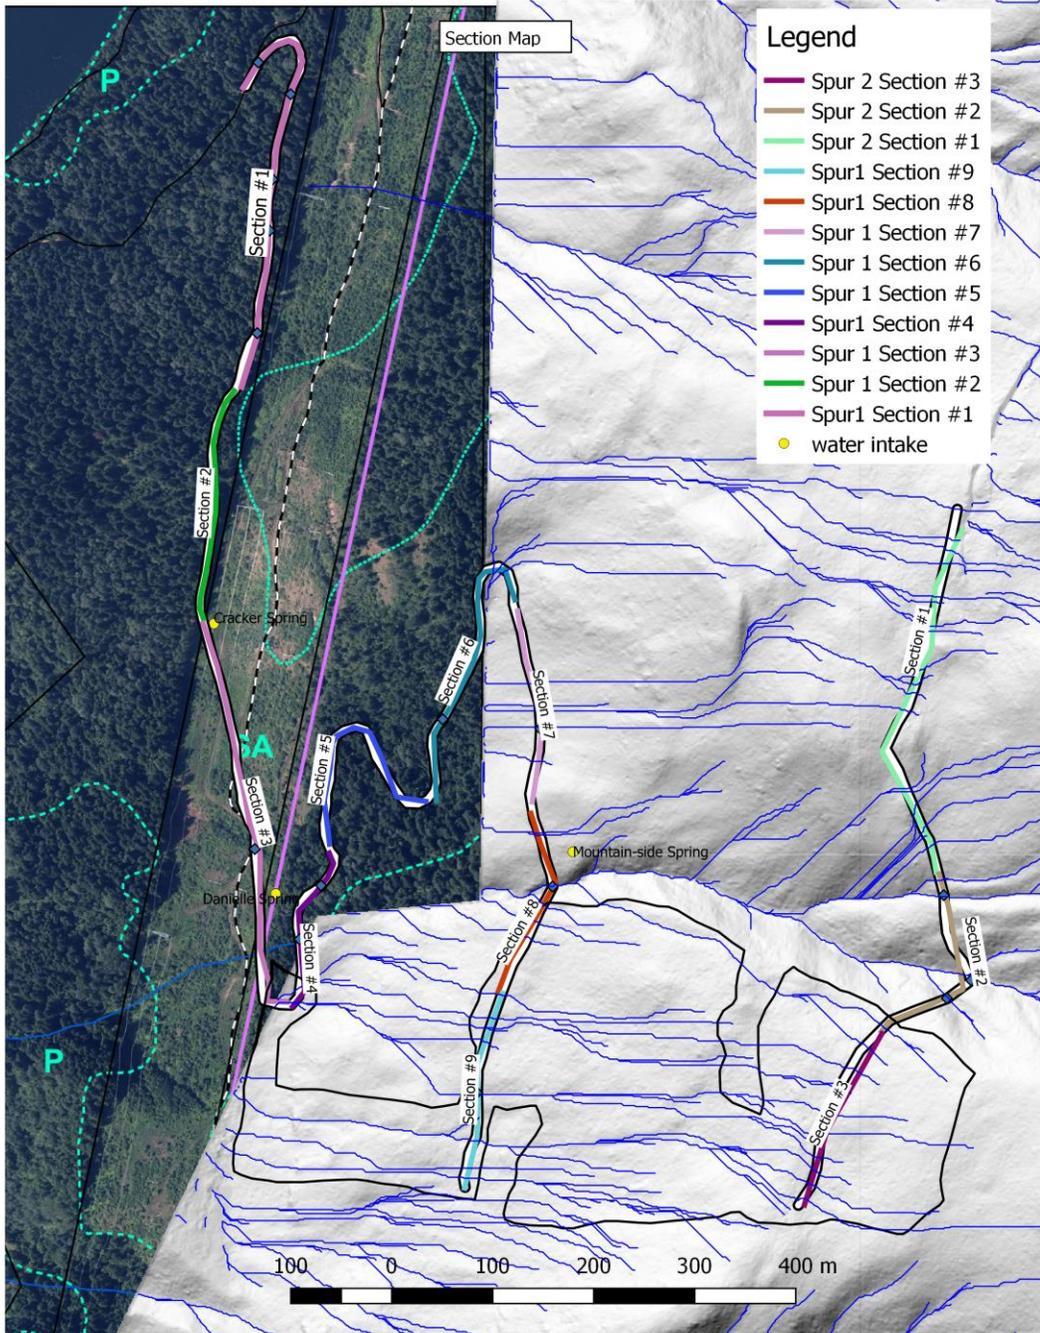
Figure 2

For the purposes of this report and for ease of discussions the spurs are divided into sections (figure #2).
