Detailed Terrain Stability Field Review

Proposed Harvesting and Road Construction
For Wildfire Interface Control in the Selous
Creek, Schesnuk Creek and Ward Creek
Areas(CP K079)
for
Kalesnikoff Lumber Company Ltd.

W. Halleran P. Geo, L.Eng.

01/08/2020

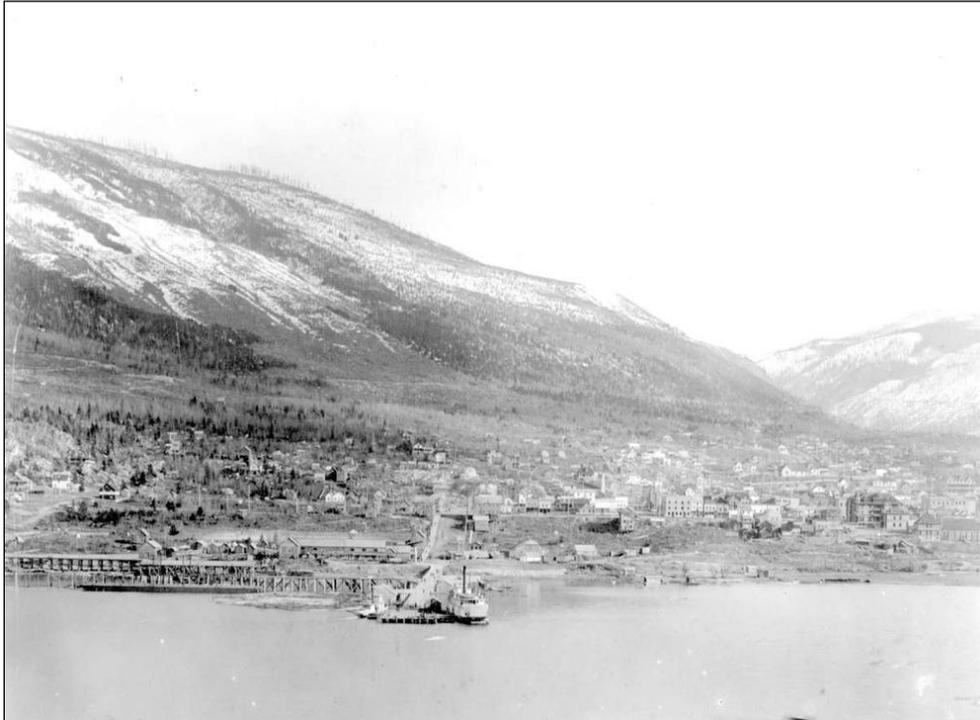
Photo 1

Archival photos of the area show that it experienced an extensive forest fire in the late 1800's which appears to have removed ~ 100% of the forest cover. The photo below is from 1892 looking south towards Ward Creek.

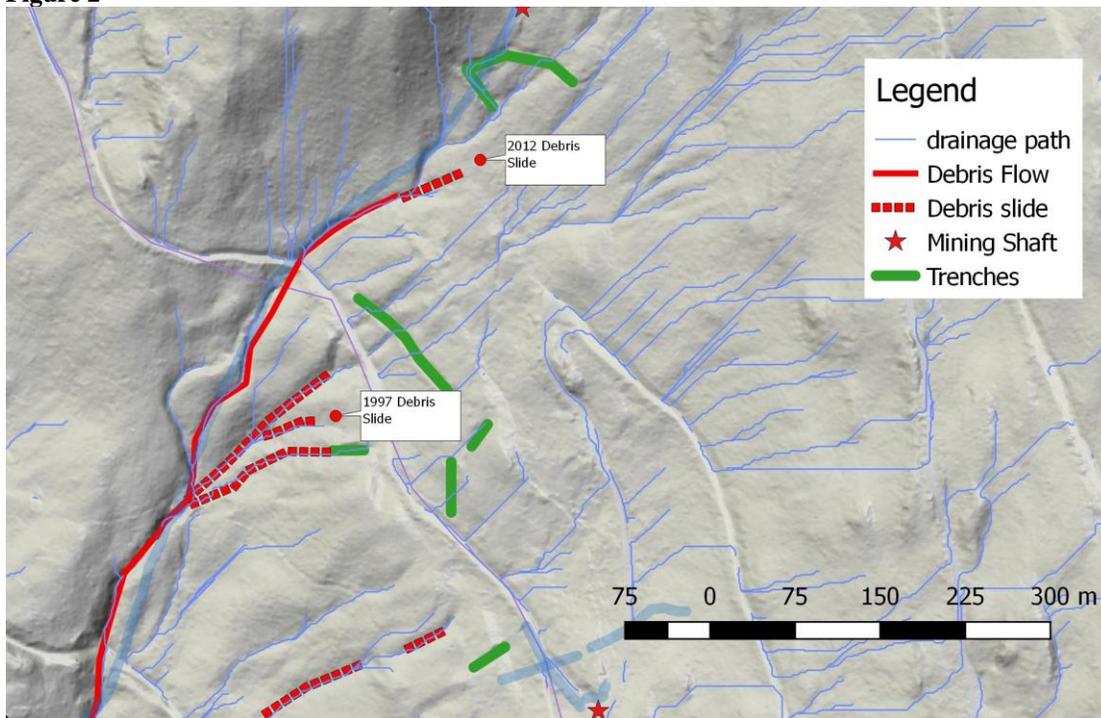
Figure 2

1997 Schesnuk Creek Slide: (Figure #2) This slide occurred in April 1997 during a period of extremely heavy rain fall and rapid snow melt (D. Putt -level C report). The fall of 1996 was extremely wet, the winter had a deep snowpack which lingered late into the spring and the extreme precipitation (Environment Canada assigned a 1:100 return) continued into the spring. The debris slide entered Schesnuk creek resulting in a debris flow down the stream gully, severely damaging a disused rail trestle, depositing significant sediment on private land and stream sedimentation into Cottonwood Creek. There are multiple headscarps at the initiation zone (Complex Headscarp). The slide initiated on a 65% slope underlain by sandy gravel till, it is possible that there was some local over steeping as a result of bulldozer trenching (1980's) pushing material onto the slope.

2012 Schesnuk Creek Slide. (Figure #2) There was widespread flooding and numerous slides in the B.C. interior in 2012, including the Johnson’s Landing slide and Fairmont Hot Springs debris flow. The deep snowpack lingered late into the spring/early summer. Between May 3rd and 6th the Maximum Daily Temperature increased from ~9 °C to >20 °C, resulting in a rapid snow melt.

debris slide entered Schesnuk Creek upstream of Spur 430 triggering a debris flow down the stream channel. At the time of assessment there were tension cracks on the crown 2m back from the scarp face. The possible upslope drainage contribution of timber harvesting was investigated. The mining trenches and road upslope of the slide were reviewed by W. Halleran, Peter Jordan of MoF, and Stan Hadikin of Kalesnikoff. A “spring” was noted flowing onto the road (trench) out of the tailings of the adit on the Lizzie showing by Stan Hadikin. Mr. P. Jordan had reviewed the logging roads upslope of the area and noted that at the time of the slide the roads were still covered in snow. On May 24th, W. Halleran followed discontinuous forest floor scour in a swale from mining road upslope into block 24-2 and noted that the possible headwater catchment of the swale had been harvested. A ridge on the west side of the swale directs water flowing from the east, down the scoured swale (Schesnuk Creek). It was also noted that parallel swales in the unharvested area had no evidence of scour.

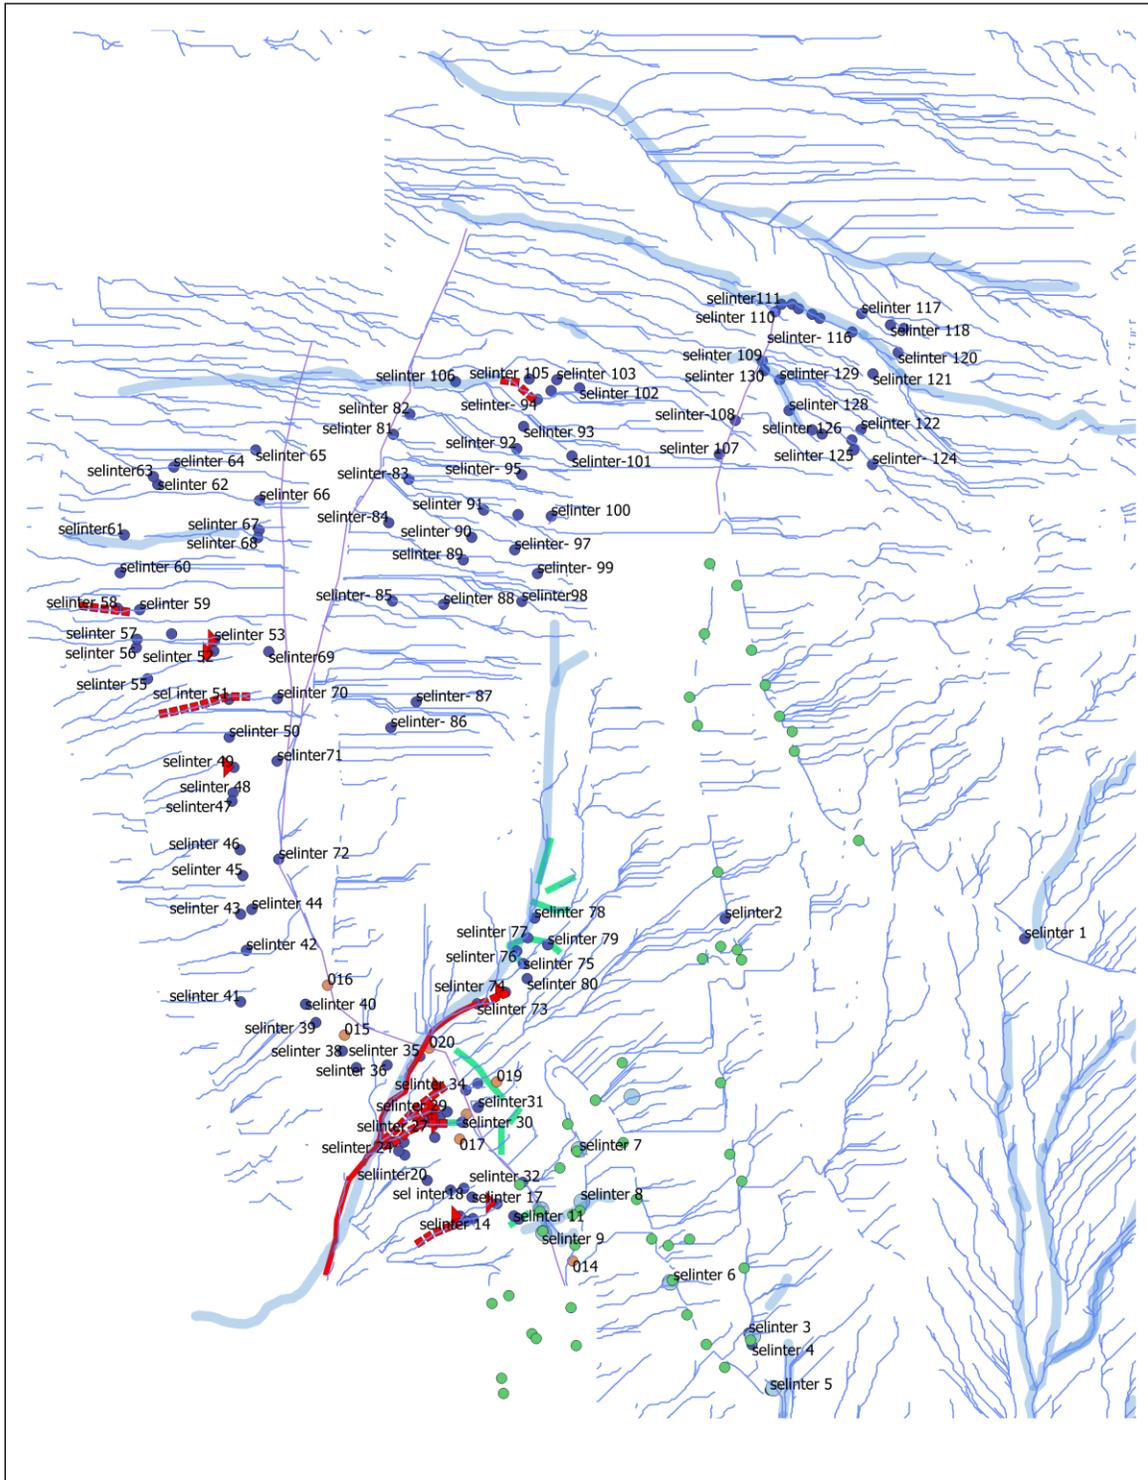
Figure 5

Information from previous dtsfa's, slide investigations, proposed road drainage assessments (CP 28 and CP 29) and Doug Thorburn's stream surveys (plotted as the wider light blue lines on figure 5) confirmed and added to the observations. It was noted that on the existing roads there are several "springs" flowing out of rock cuts with no associated surface expression, usually 1-2 meters below the ground surface, likely associated with small shear zones or contacts in the volcanics. Prior to road construction of the existing roads several surface springs (some with associated caliche) were also noted and mapped.

Except for Schesnuk Creek, there is very little natural concentration of slope drainage within the development area. Most of the slope drainage pattern is dispersed over the face with numerous parallel to sub parallel features.

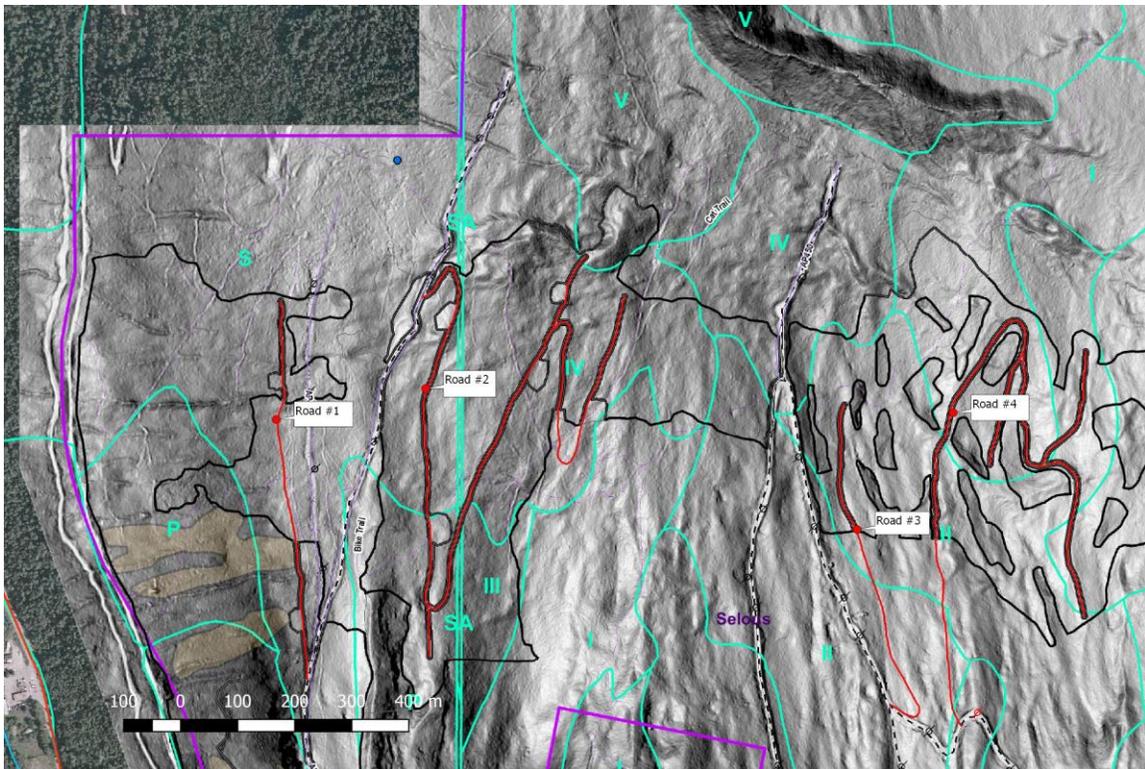
Figure 12

There are four new roads proposed for this development. For the purposes of this report the roads are designated Road #1, Road #2 , Road #3 and Road #4. (figure 12). Roads 1 and 2 were traversed during this assessment, the area north and downslope of Road 4 was inspected to determine and possible impacts to Ward creek. Road #3 was not field assessed, the road is immediately upslope of the existing Main Road.
